An Introduction to the Bramayani Conservation Project, Panauti

—John Sanday

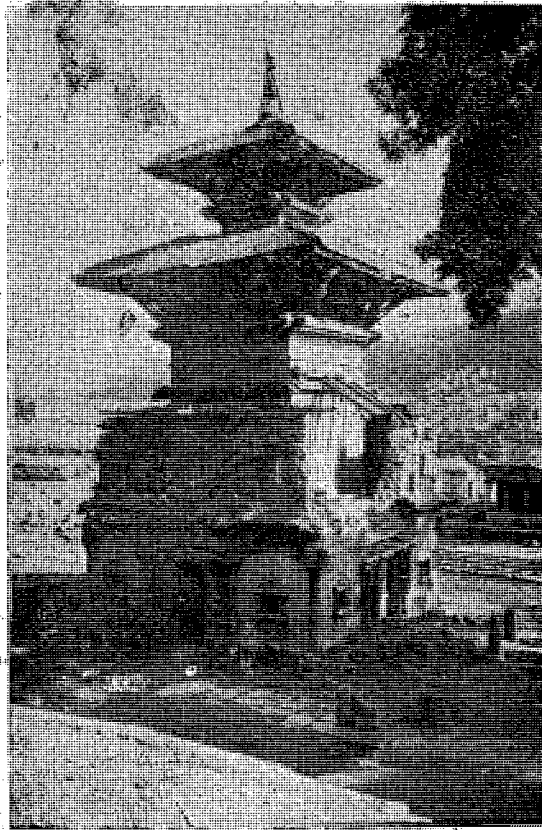
the structure. Because of the collapse of at least 75% of the roofs, the structural core had been exposed to the elements causing considerable degradation to the timbers and brickwork.

Before Conservation: Bramayan Temple, Panauti

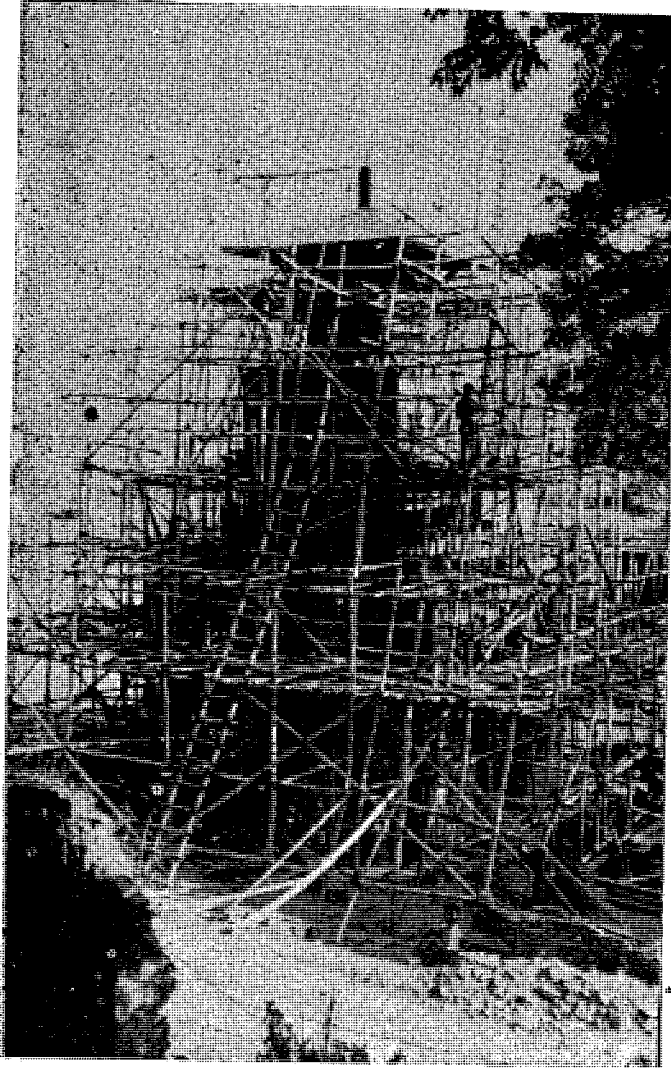
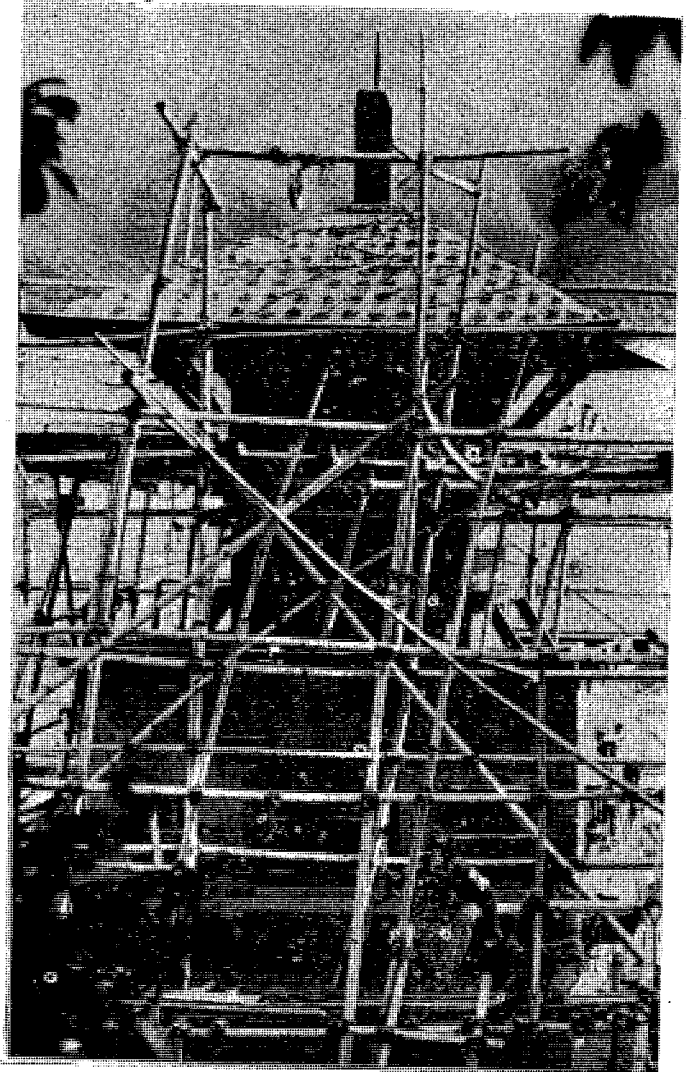
During Conservation; Bramayani Temple, Panauti

Prior to the insertion of these foundation pads, the whole of the central core of the structure had to be shored into position, and attempts at this stage were made to try and jack the structure back into its original position. Great care had to be taken during all these operations not to disturb the fresco which lined the upper walls of the sanctum as the divinities depicted on them could not be unsolved. Attempts therefore at rectifying the structure had to be abandoned. After the whole structure had been correctly braced and shored, and area of 1 metre square and 20cms deep was excavated

beneath the existing padstone to the timber columns. A cage of reinforcing steel was carefully set under the columns and pad stone, and a concrete mix was floated a few millimeters above the padstone to avoid any settlement once the temporary supports had been removed. Two columns were consolidated at a time allowing a period of two weeks to elapse to ensure the maximum curing of the concrete. After the foundation work was satisfactorily completed the process of renovation started from the topmost part of the building downwards could commence.

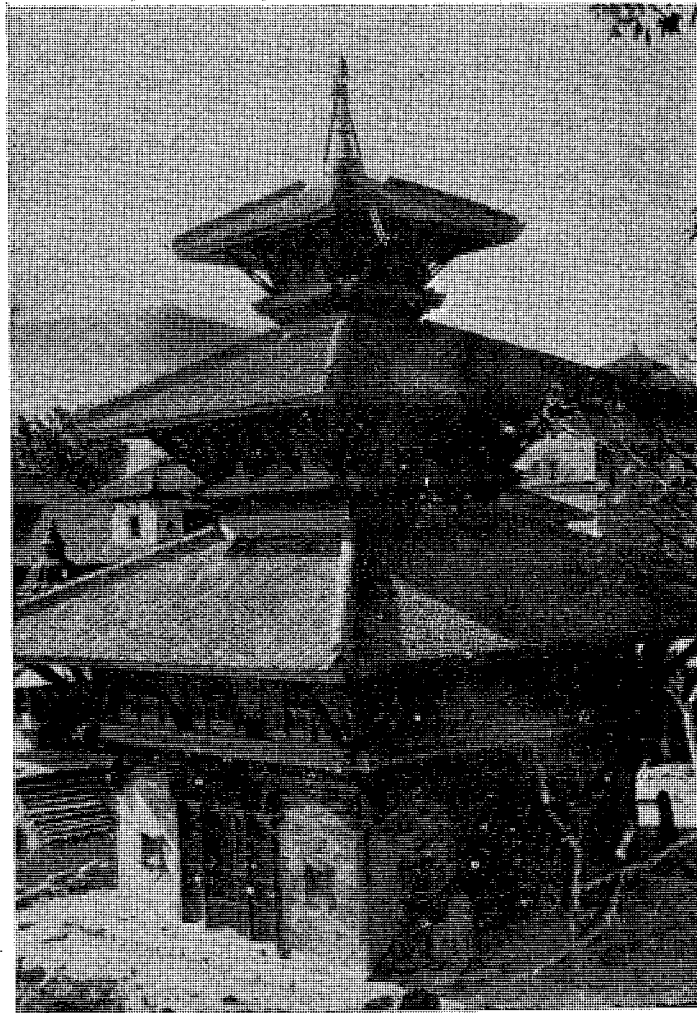
After Conservation; Bramayani Temple, Panauti
