# KAGBENI : Structural Analysis of Dendrochronological Data

- Niels Gutschow

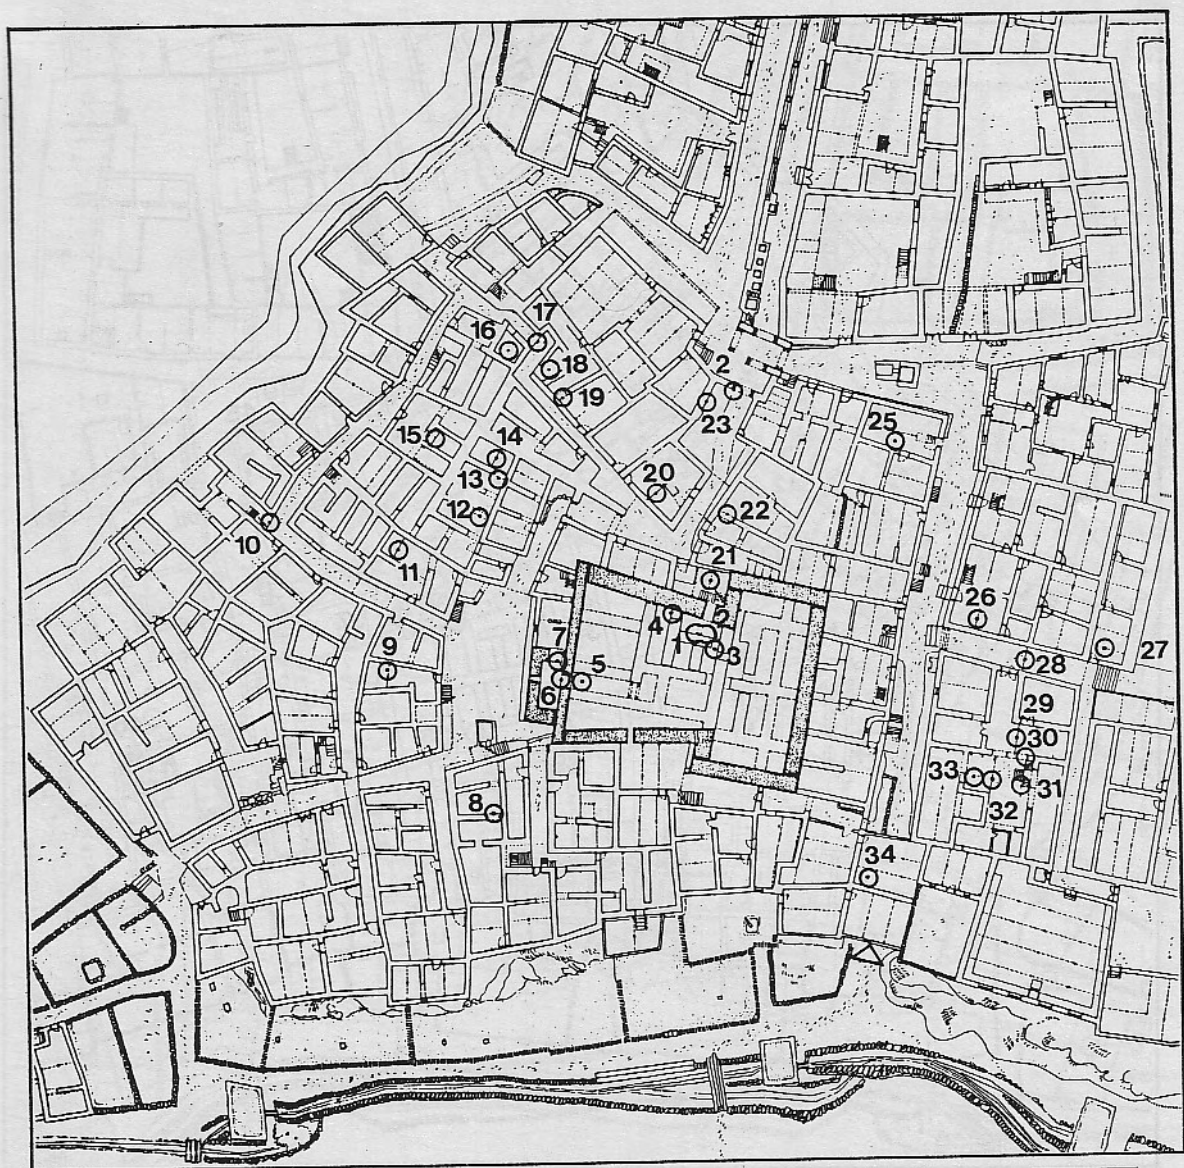
**Kagbeni, historic core of the village :**  
Location of samples 1 - 34 on ground floor level.

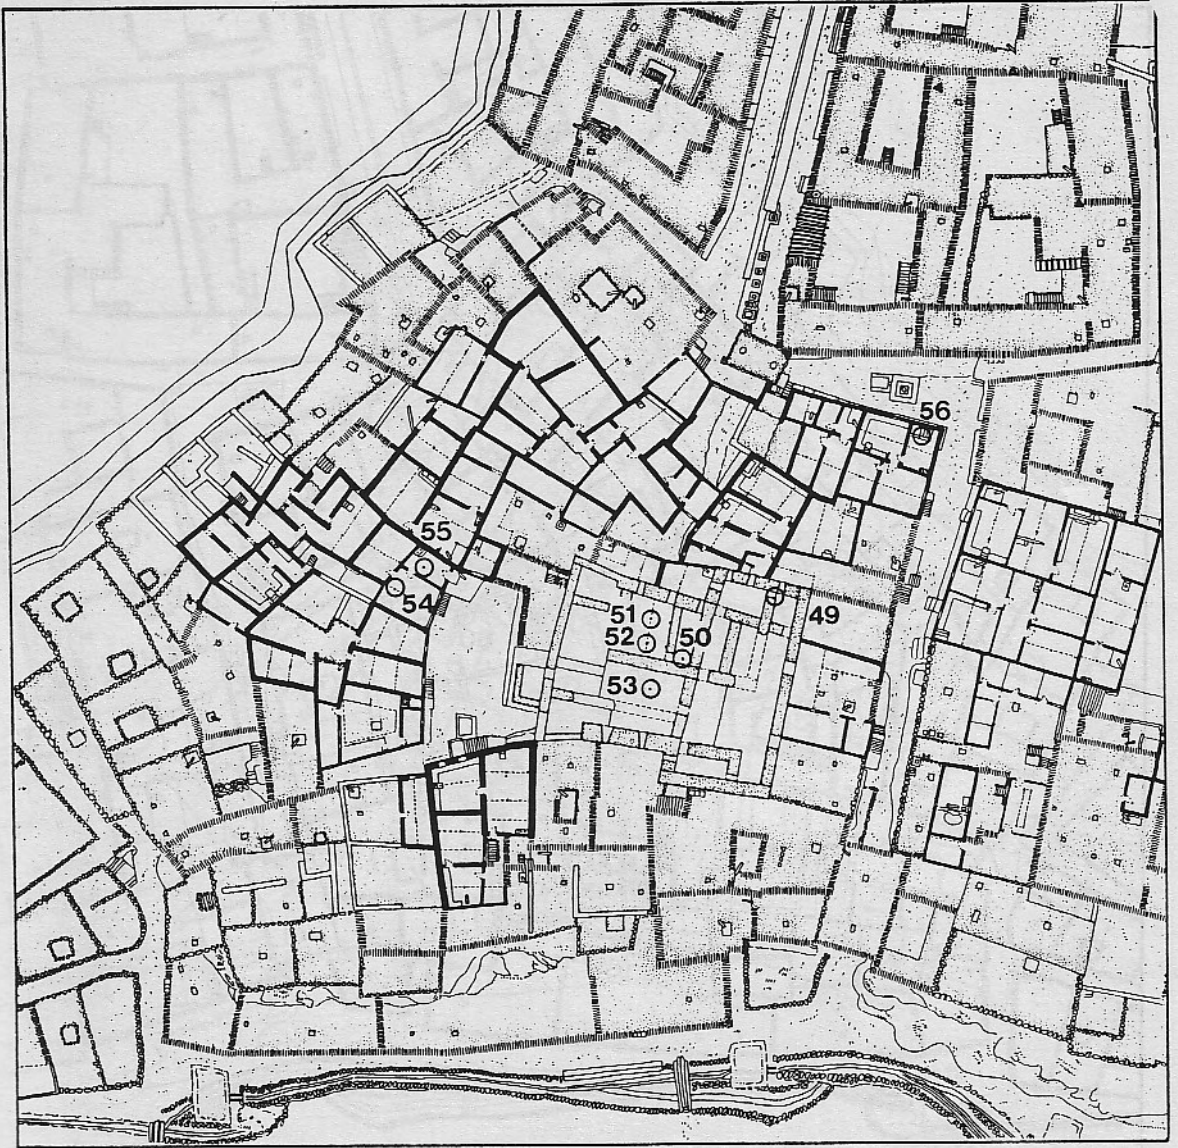
**Kagbeni, historic core of the village :**  
Location of samples 49 -50 on **third floor level.**

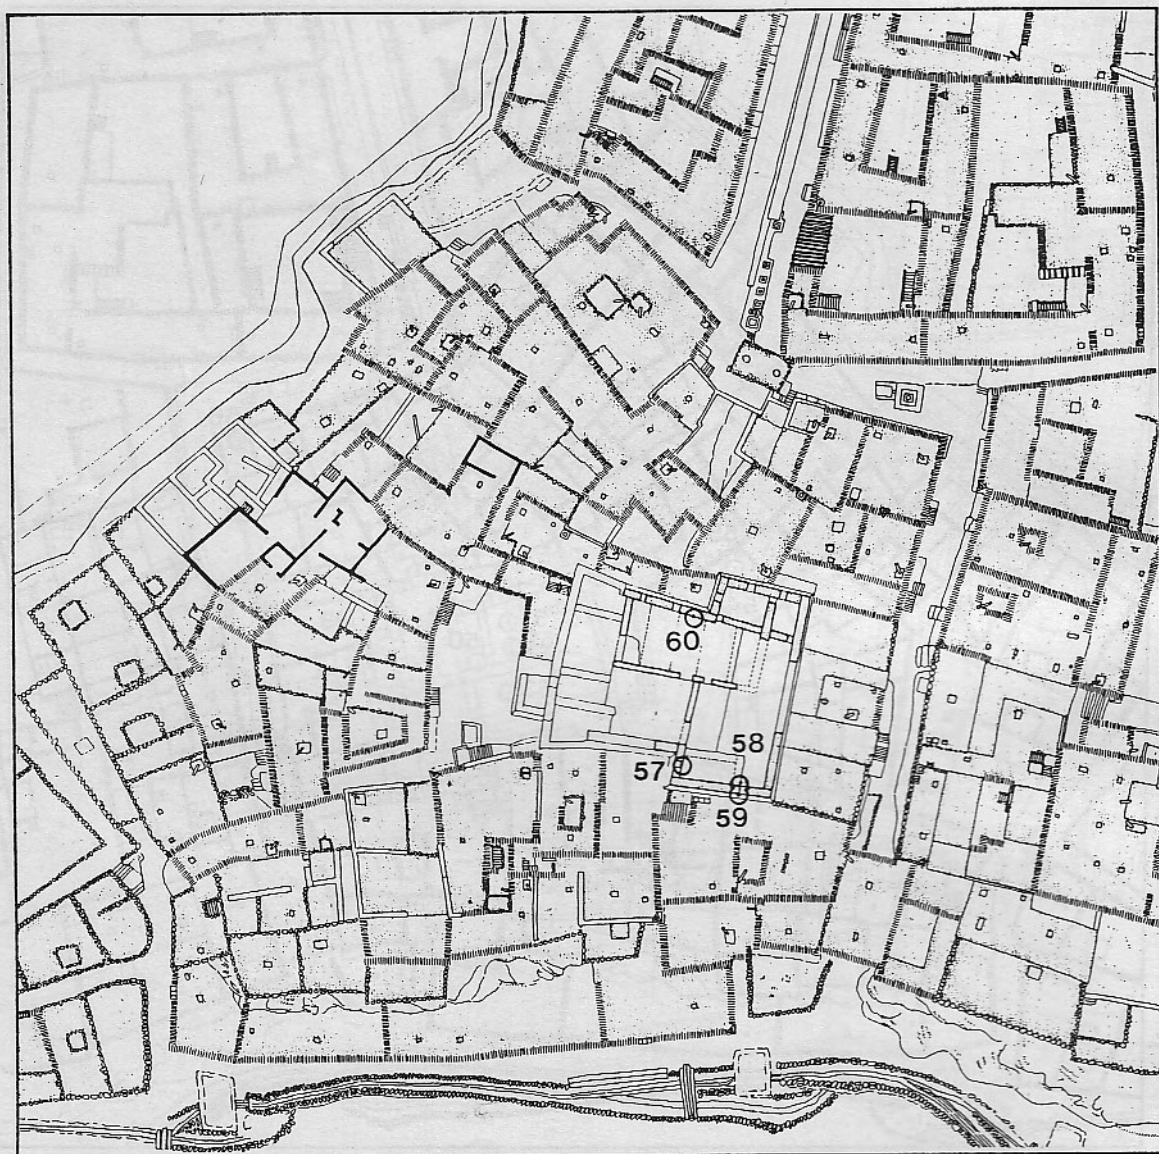
**Kagbeni, historic core of the village :**  
Location of samples 57-60 on **fourth floor** level of the castle.

There is one sample from the fourth floor, the date of which does not at all fit into the pattern explained above. It originates from a board of a putlock on the northern facade that remained there from shuttering. The date 1568 suggests a reuse after a period of more than two hundred years.

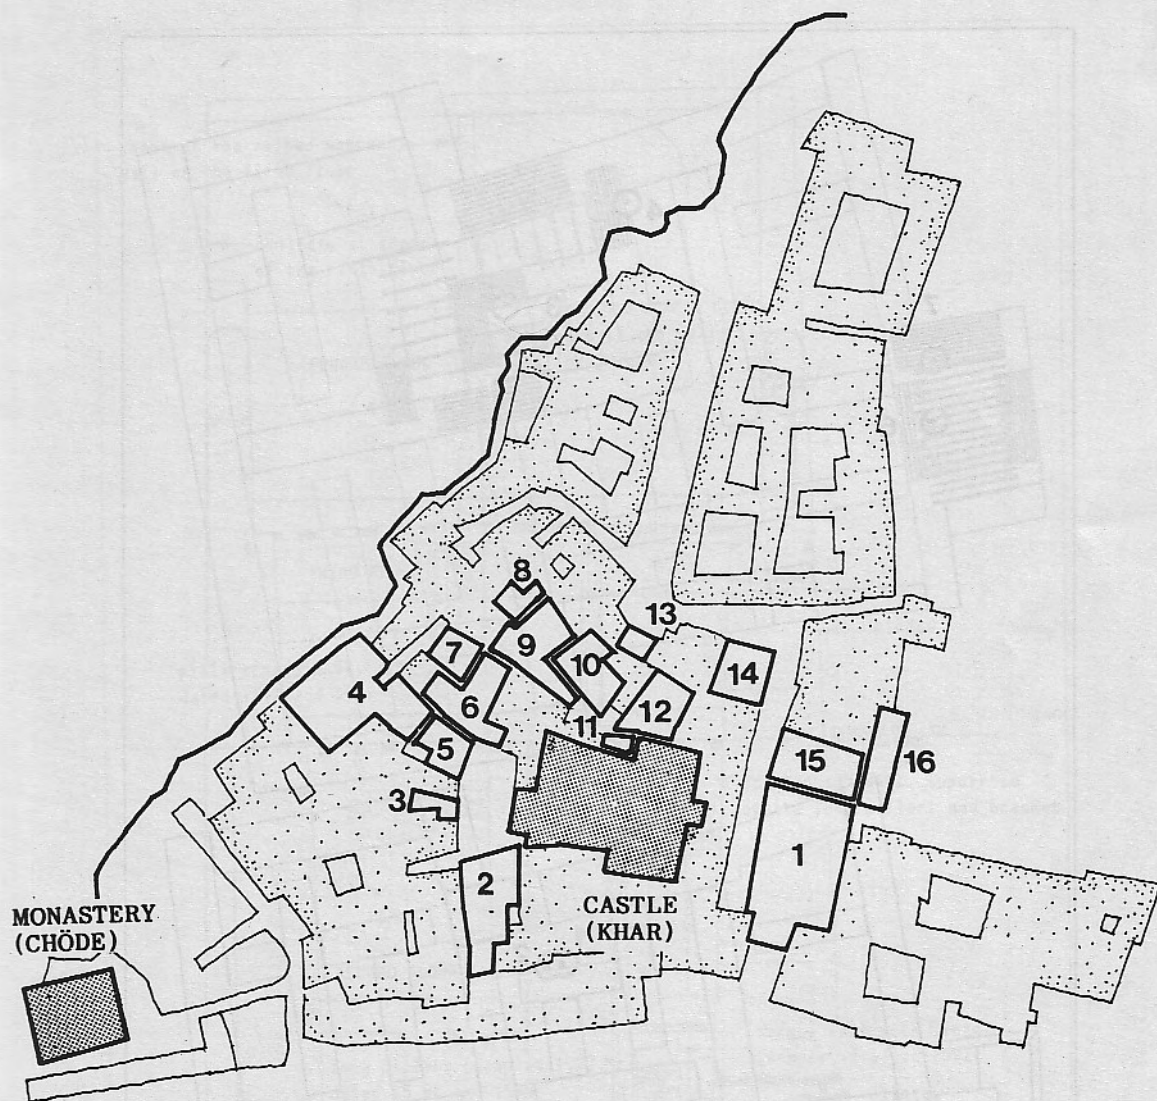
Kagbeni Village, site plan second floor level, scale 1:1000

Identification of houses from which samples were collected for dendrochronological analysis in 1992 and March 1993

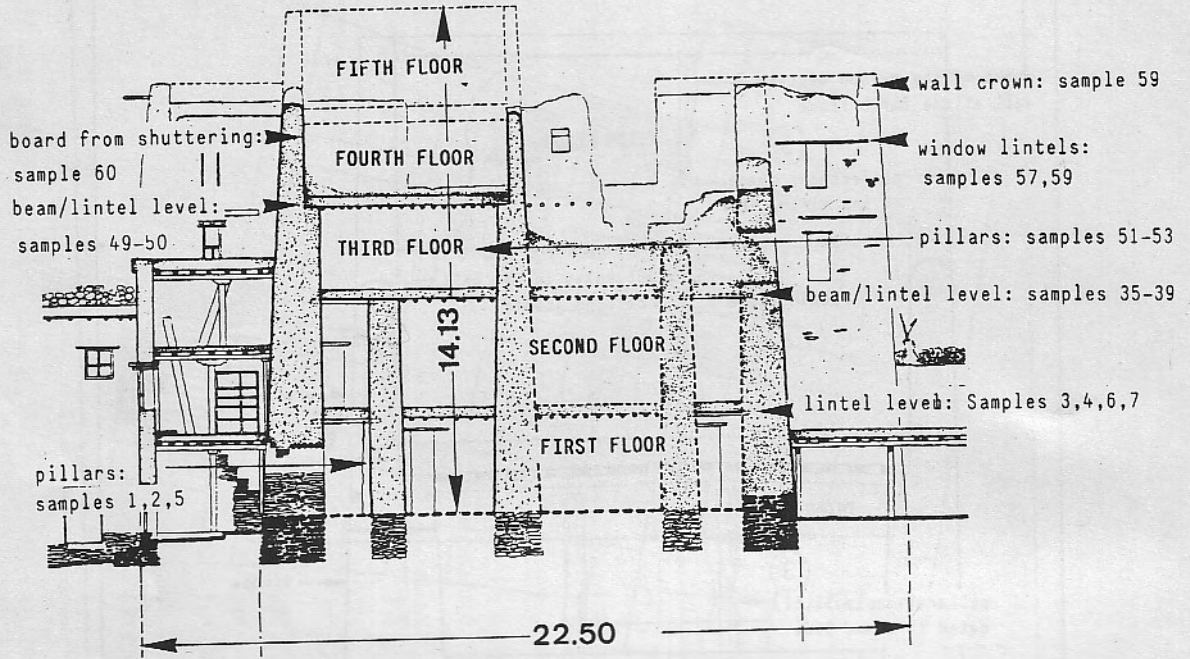
**Kagbeni Castle, North - South section, scale 1:200**  
 Identification of levels from which 20 samples for dendrochronological analysis were collected in March 1993 and 1992 (samples 53, 60)

Altogether 21 dated samples from the castle have been taken : Seven from ground floor level, five from the second level, five from the third level and finally four from the fourth level. No timbers survived on fifth floor level. There, the joists and beams have been salvaged, only a row of holes indicate the level of the ceiling joists.

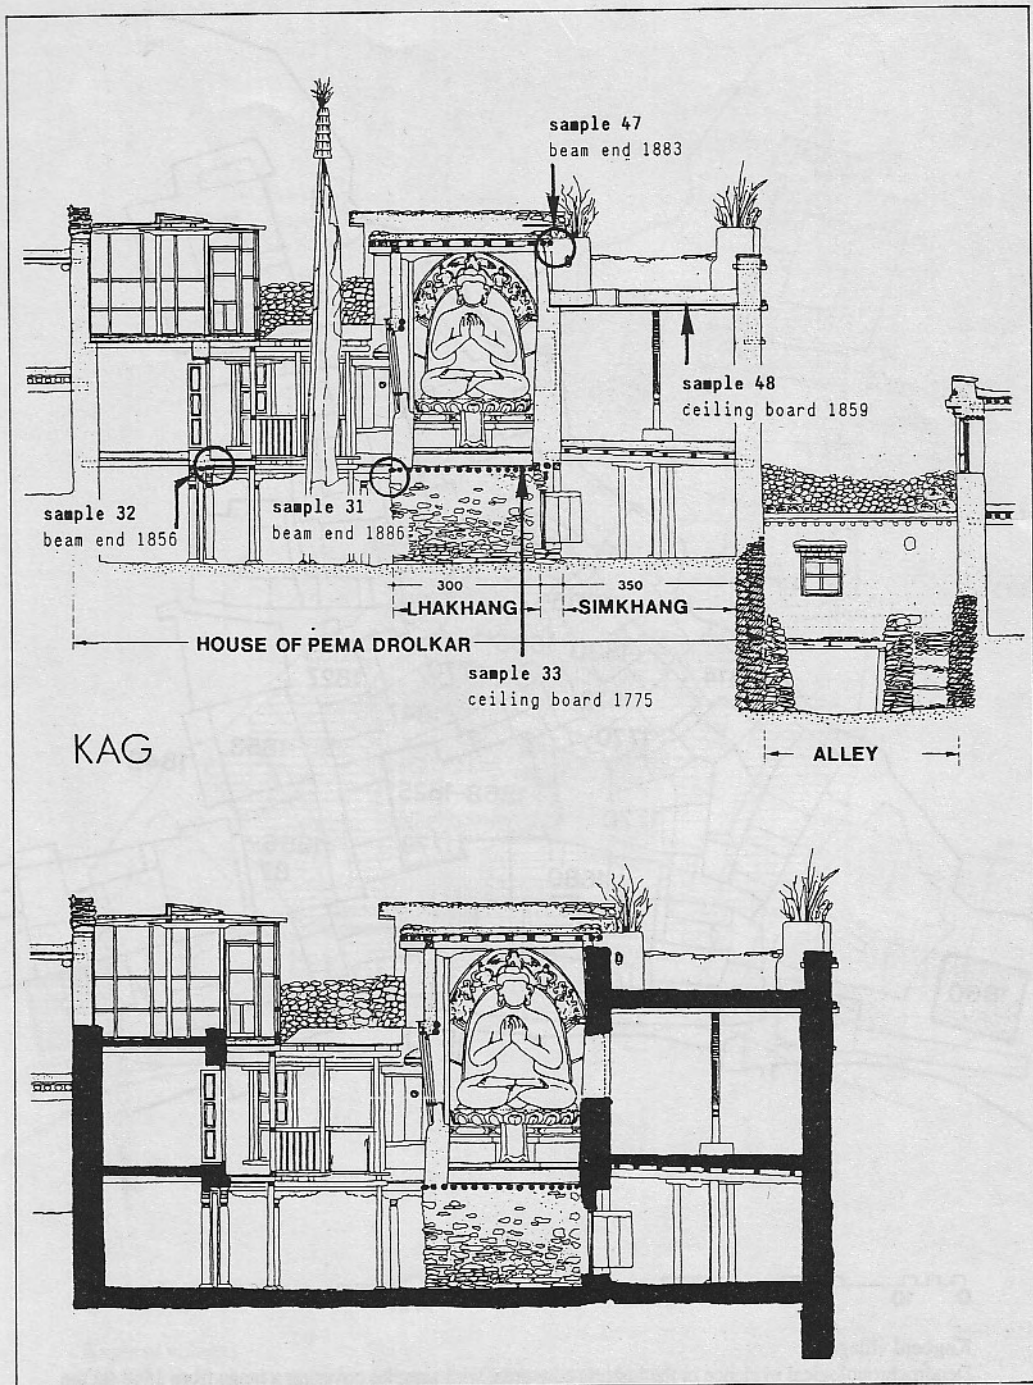
**Kagbeni, House of Pema Drolkar, East - West sections through Simkhang and courtyard.**  
 Identification of samples 31, 32, 33, 47, 48 (above) and conjectural section below after the first phase of construction around 1860 AD with Simkhang (right), large courtyard and stables (left).

painted. Obviously this room served as the ritual room of the noble family in the initial stage of development. Known by the name of 'Kanjur Simkhang' (gzims-khang-honorific term for 'room') the room recalls the Kanjur corpus of sacred books that were once stored here.

In a second stage of construction activities the Kanjur Simkhang seemed not to be appropriate any more to demonstrate the status of the family. A new hall of 330 cm width, the Lhakhang was therefore added to the Simkhang side, thus crossing the former courtyard. The new hall had to be made 120 cm higher than the old hall in order to house a colossal Vairocana statue on a raised pedestal and enshrined by a fully carved tympanum. The new hall is supported by a simple pillar and capital structure, while the capitals of the initial arcade display detailed carvings based on lotus patterns. Below the colossal statue, however, a massive block of stones serves as a kind of extended socle. In a third stage of development the building was transformed into a lodge in 1986. The two long narrow rooms on the eastern and southern sides of the courtyard were rebuilt and subdivided into four guest rooms. In 1991 three more rooms and a glazed conservatory were added on top of the roof, and an additional guest room and stables built to the South.

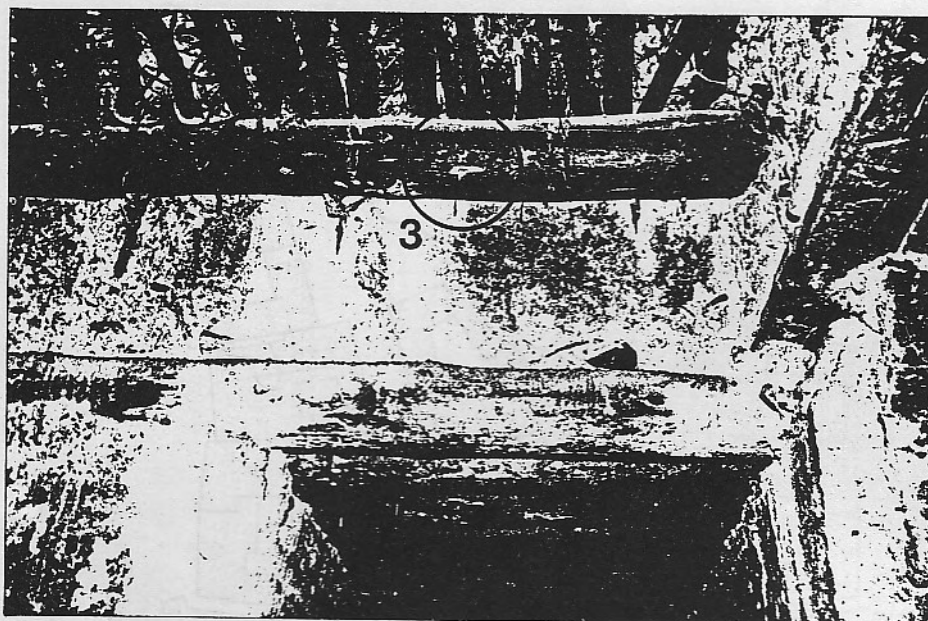
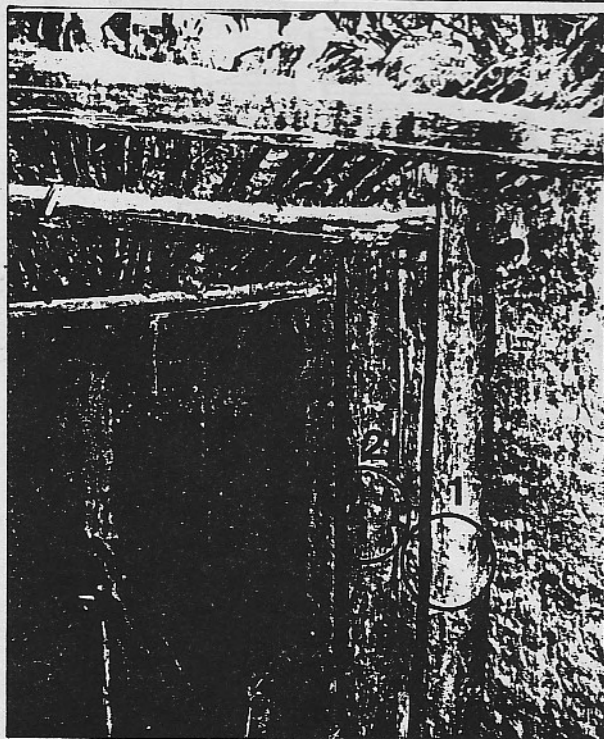
**Kagbeni Castle, ground floor level :**  
Samples 1 and 2 (1993) : Core of two columns extending over two floors to support lintels of the upper level, dated 1586 and 1595.  
Sample 3 ( 1993) : Core of a ceiling joist, dated 1581.

The most crucial structural elements, the pair of pillars extending over two storeys, are dated to 1586 (sample 1) and 1596 (sample 2) at the northern entrance and 1572 (sample 5) at the western entrance to the castle. The remaining dates cluster around 1600, ranging from 1581 (sample 3) to 1622 (sample 4). The exceptional date of 1683 for a lintel at the western entrance can be explained more easily, as the western extension represents a more recent reshaping of the access in order to comply with changing concepts of security and defence. While the straight northern entrance remained unchanged, the main entrance at the western side, from where a staircase led to the upper levels, was changed into an L-shaped one.

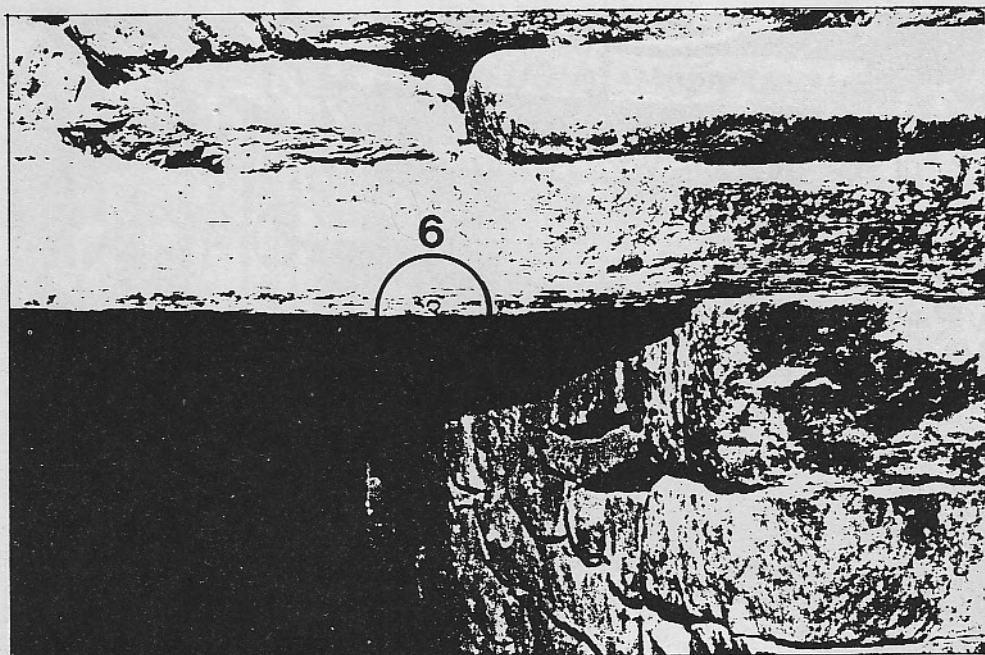
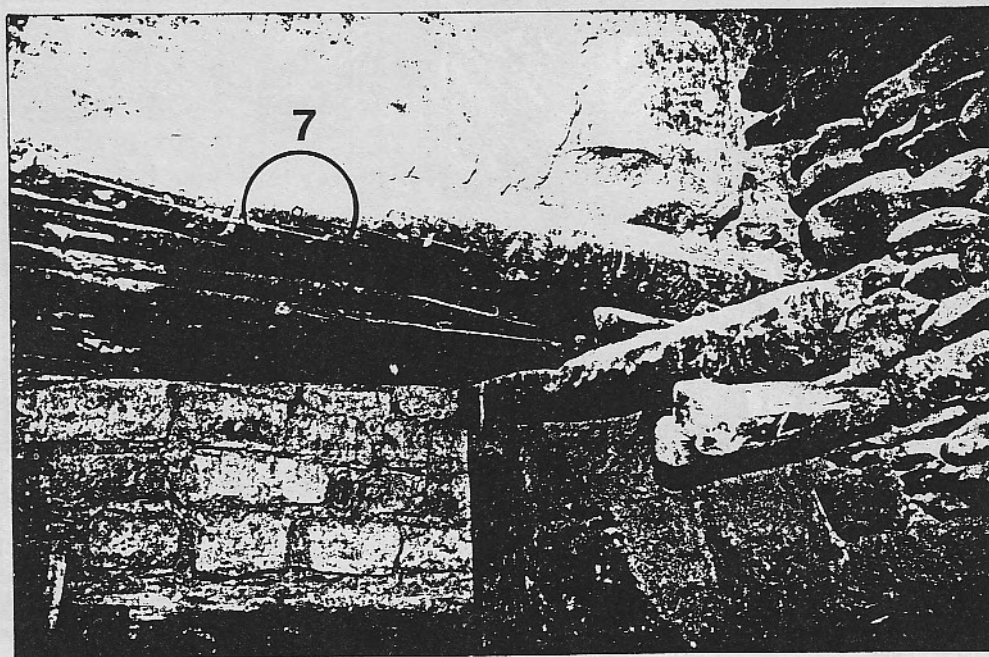
Kagbeni Castle, ground floor level :

Sample 6 (1993) : Core of the foremost lintel of the western entrance, dated 1600.

Sample 7 (1993) : Core of the innermost lintel above the addition to the western entrance, dated 1683.

The lintel from the western entrance, dated to 1683 suggests the redesigning of that portion of the castle towards the end of the 17th century. The end of the 18th century saw massive interventions and changes of the fourth floor, probably including the addition of the fifth floor.

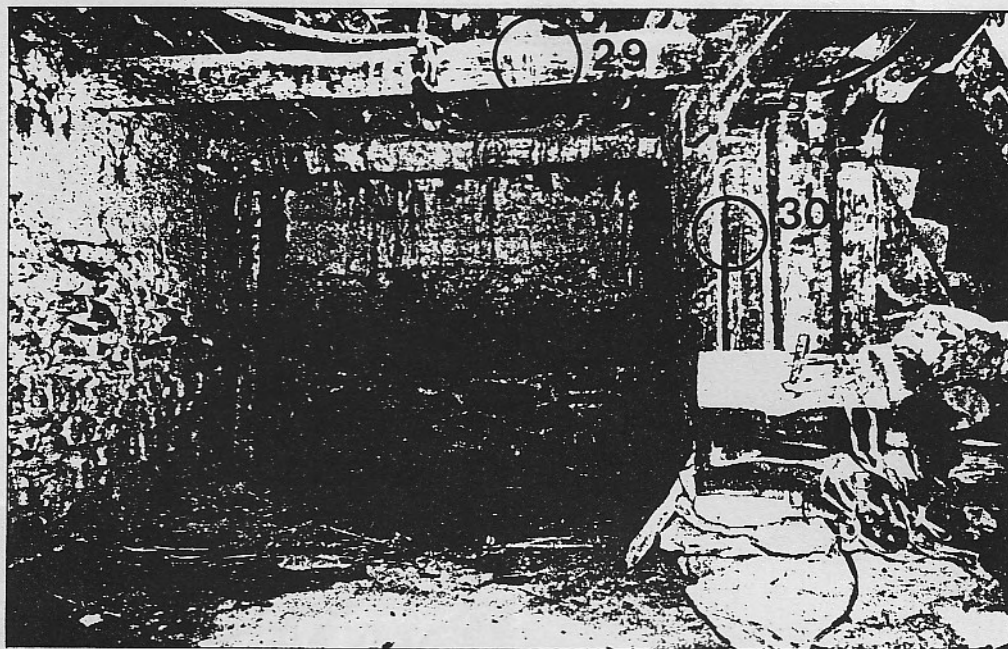
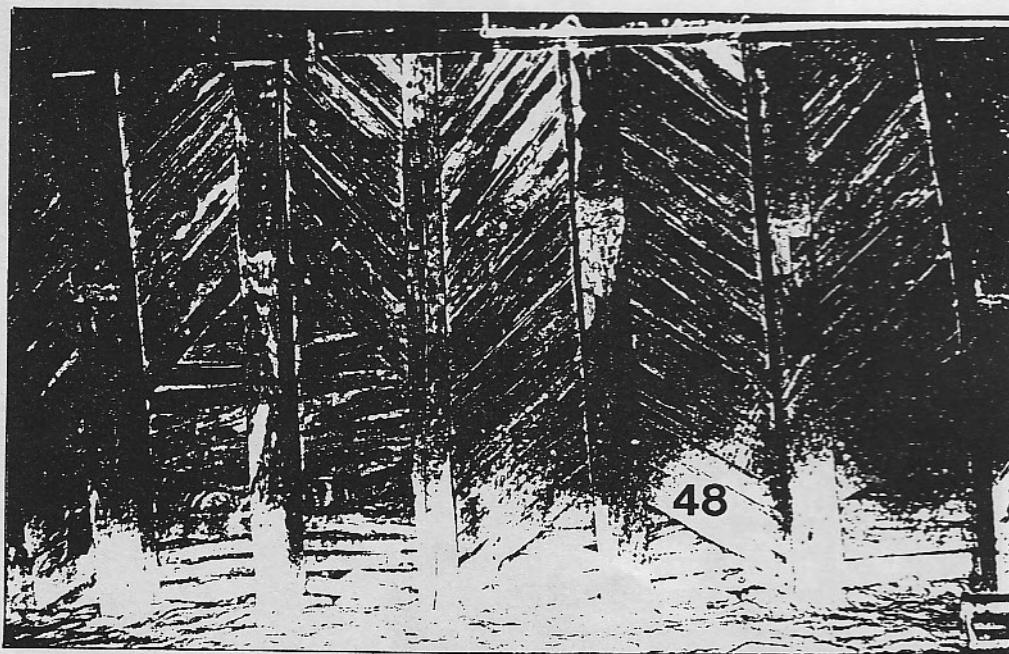
**Kagbeni, Pema Drolkar's house (called Red House) :**

Sample 29 (1993) : Core of a tie beam at ground floor level, dated 1843 (+/- 10 years)

Sample 30 (1992) : Core of a column at ground floor level, dated 1887.

Sample 48 (1992) : Board of the ceiling above the ritual chamber of the second floor level, dated 1859.

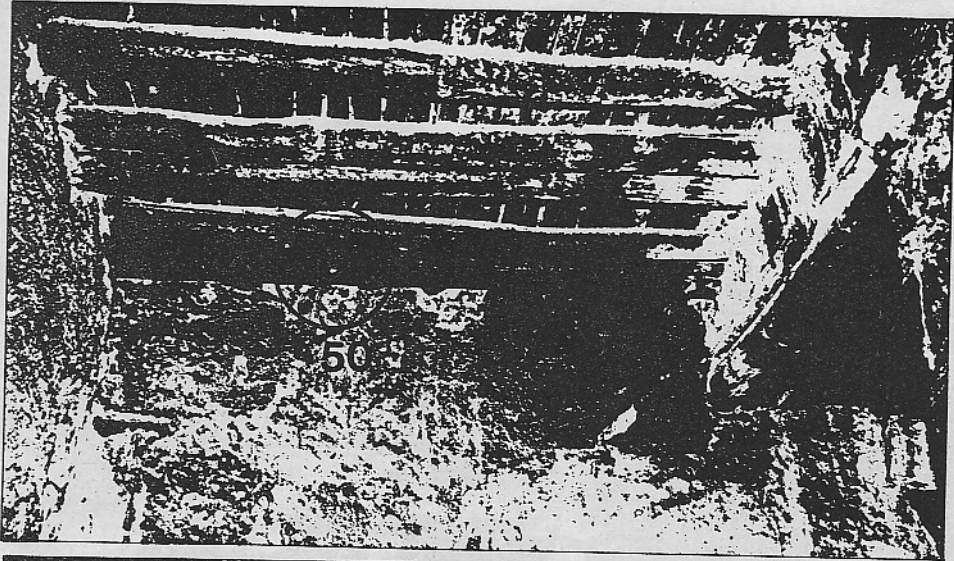
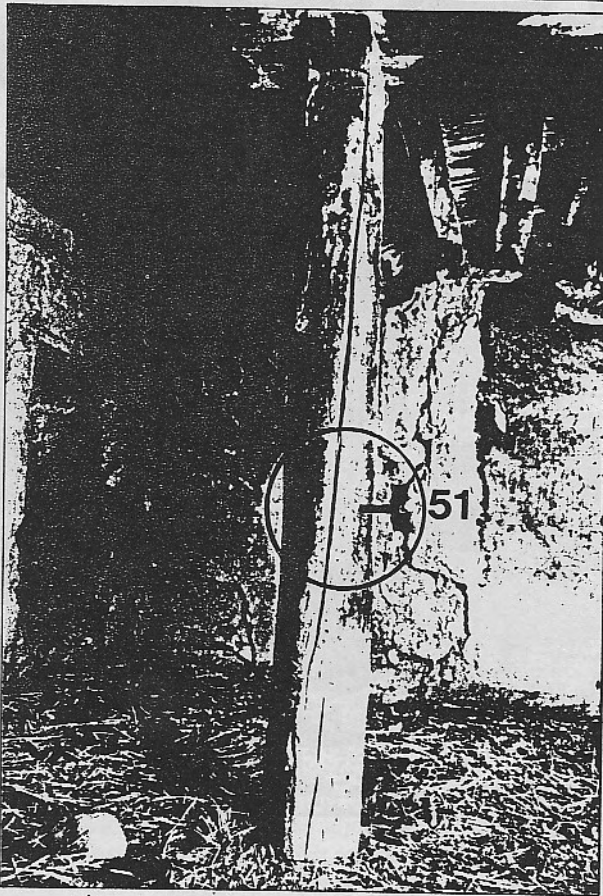
Kagbeni Castle, third floor level :

Sample 50 (1993) : Core of a ceiling joist, dated 1596.

Sample 51 (1992) : Core of a column supporting a tie beam, dated 1572.

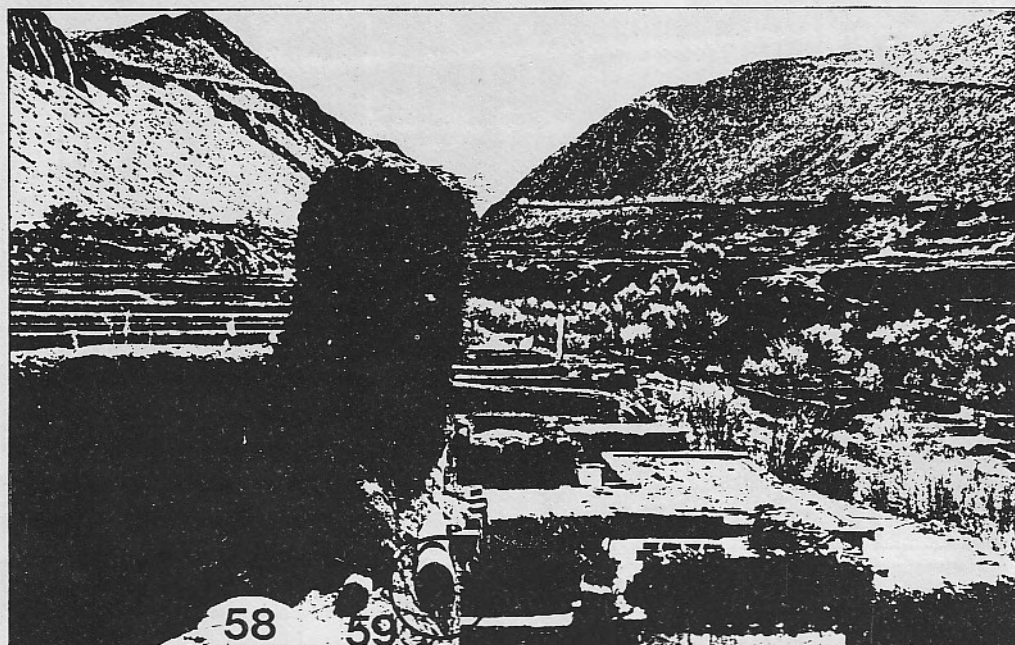
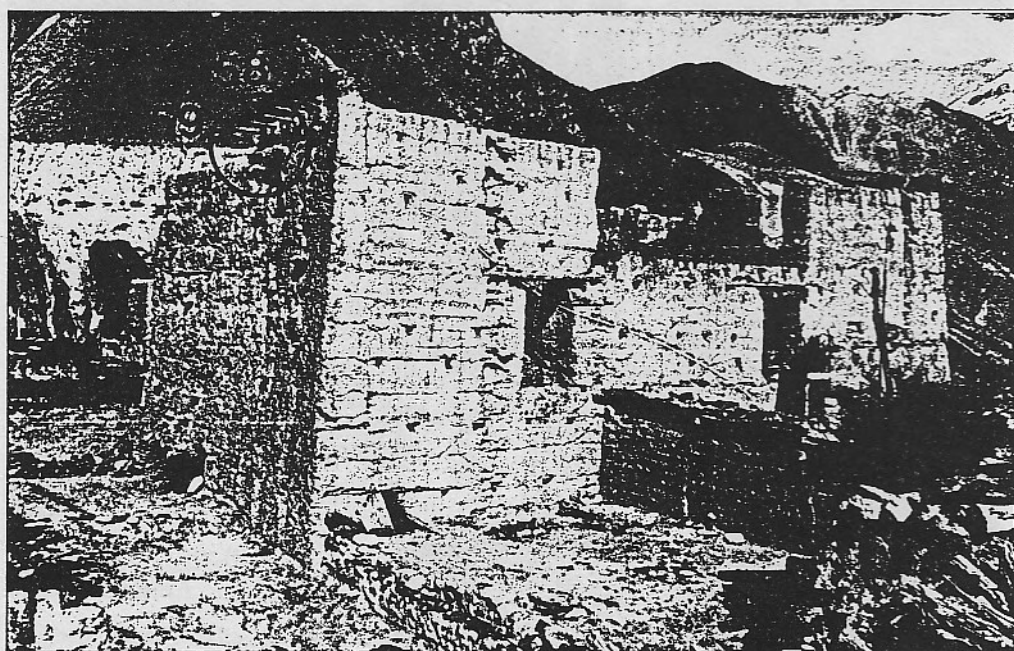
**Kagbeni Castle, fourth level (top floor) :**

**Sample 58 (1993) :** Cut end of a secondary lintel, dated 1779.

**Sample 59 (1993) :** Cut end of a horizontal raft above a window lintel, dated 1779.

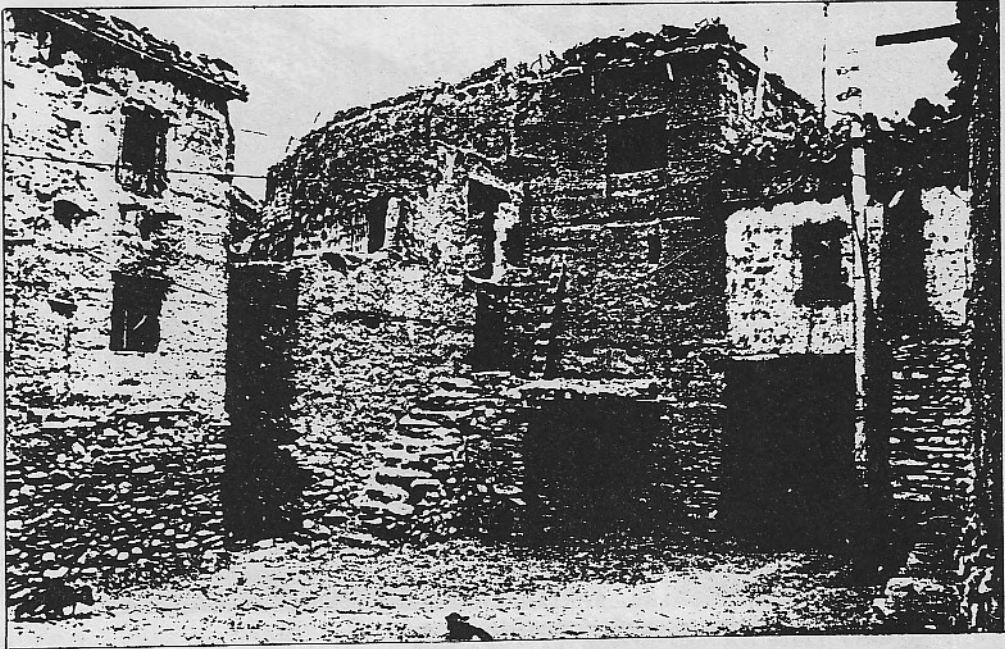
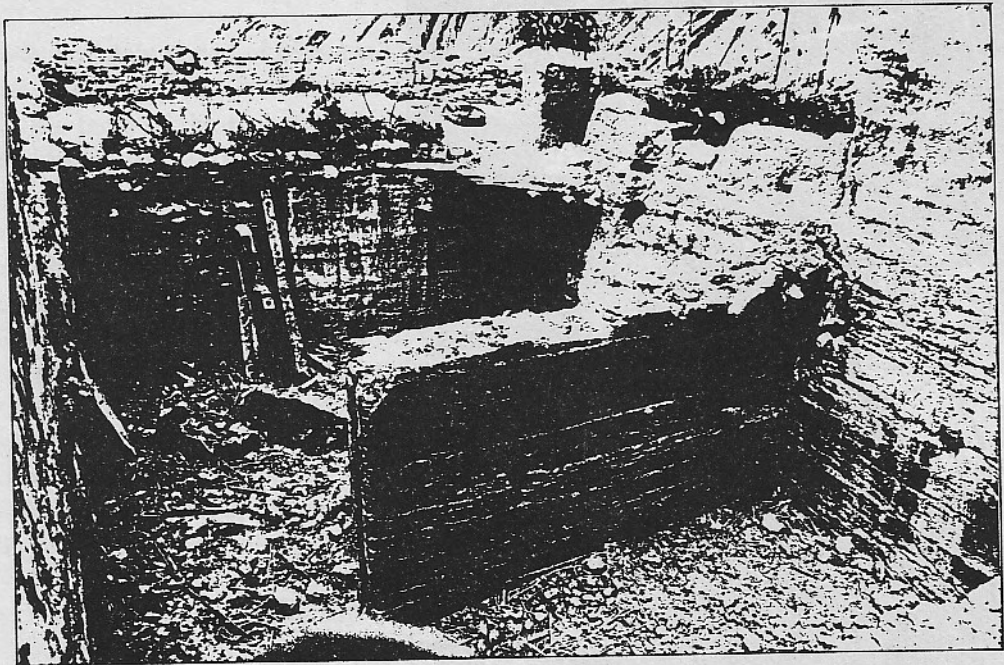
**Kagbeni Village:**

Demolition of ancient houses adjoining the village square (Te). Above house 5 (Mingmar "A") with ceiling beams dated 1770 (first and second floors), below the demolished third and fourth floors of house 6 (Samdruk) with lintels and ceiling joists dated to 1572 at first floor and pillars and joists dated to 1771 on second floor level. Both were demolished in May 1993, foto June 15, 1993.

5) demolished his house : The joists and beams were removed for reuse, only the bleak mud walls remained. The ground floor was rearranged to serve as a store for hay and straw. Mingmar's neighbour (house 4) in turn joined in demolishing parts of her house that had already been in ruins for many years. The way the timber is recovered from existing houses might throw a light on the availability and costliness of timber in general. As a commodity it is used over and over again : A joist will be reused as a joist and a beam as a beam. There is no reason to believe, that the general practice differed a century of two ago.

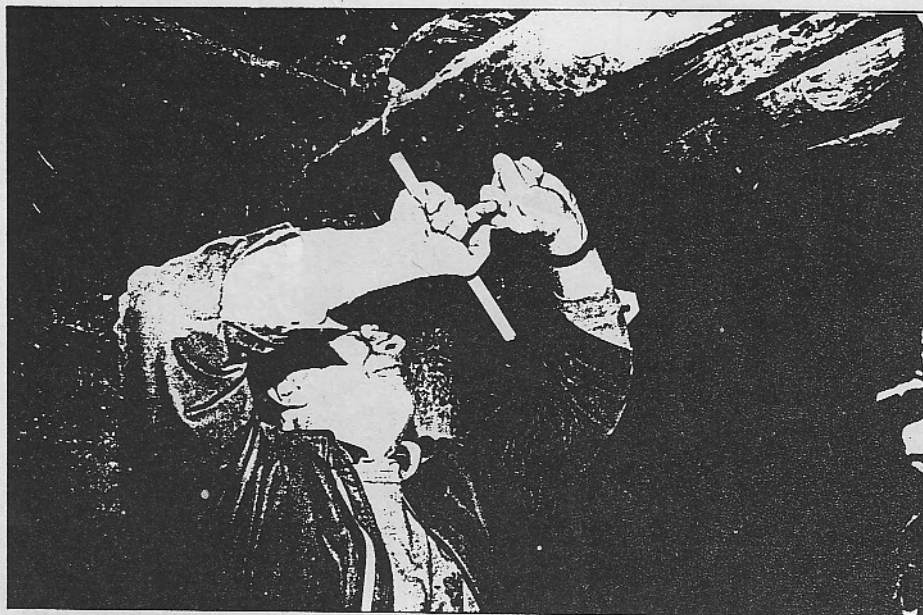
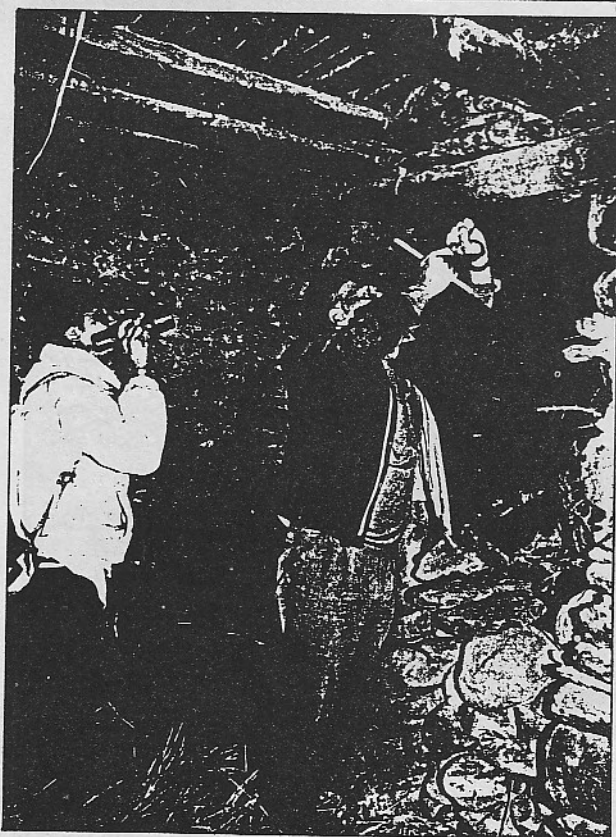
**Kagbeni, house south of the square :**  
**Sample 8 (1993) : Core of a lintel above an opening between two rooms, dated 1680.**
