“Chemical Conservation Of Monuments”

-Griha Man Singh

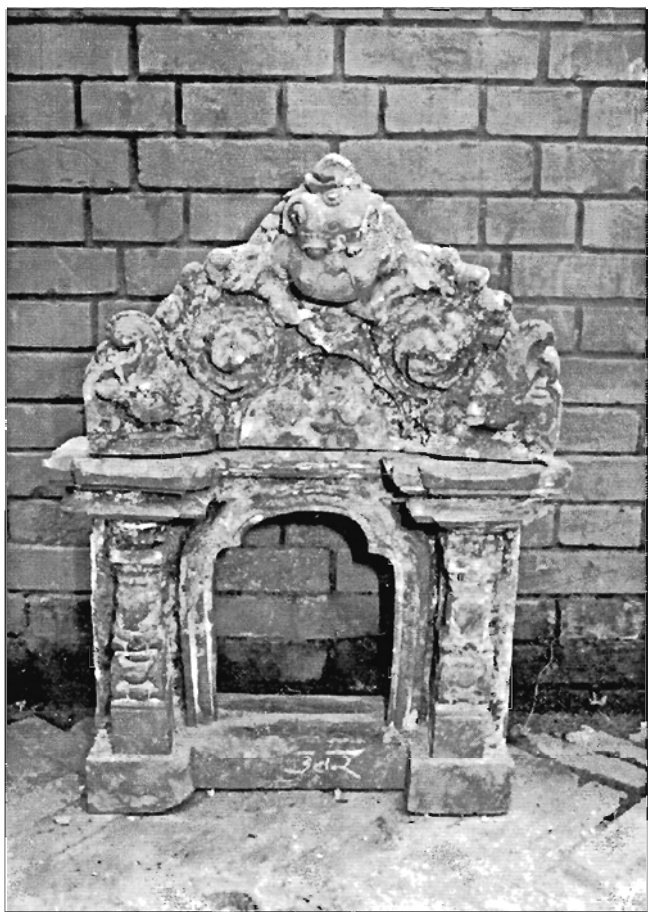
Terracotta before cleaning
(Deteriorated by white calcarious material deposition)

Around the middle portion of the temple at four sides East, West, North and South, there are beautiful decorative terracotta object of different varieties i.e. arts of god and goddess, such decorative terracotta objects were highly deteriorated by white colour salt formation. Such salt formation is caused due to the environment, pollution and chemical effect. There are different view of formation of white color solid salt, was identified as Calcium Carbonate or chalk, because of effervesence with Hydrochloric acid possible reaction as below:

Here also atmospheric Carbondioxide reacts with atmospheric moisture under suitable condition form Carbonic acid, on reaction with Calcium Carbonate which form Calcium bicarbonate. Some time Calcium bicarbonate react with Calcium Hydroxide and form Calcium Carbonate and water. Such Calcium Carbonate appeared as white solid materials on the surface of the terracotta objects, it looks ugly and finally they are filled in the carving portion of the terracotta object.

White calcarious materials or calcium carbonate deposited on terracotta object removed or cleaned by using 5-10% aqueous Acetic acid solution using soft brush, knife and needle, the chemical reaction of this treatment as follows

Here calcium carbonate reacts with Acetic acid and form soluble salt of Calcium Acetate, Carbondioxide gas and water. Some of the Calcium Carbonate and Calcium Acetate may still be present in terracotta object, removed by mechanical method. After removing all the white solid materials, thoroughly wash out with neutral detergent to remove all the acid from terracotta object, leave them to dry at room temperature.

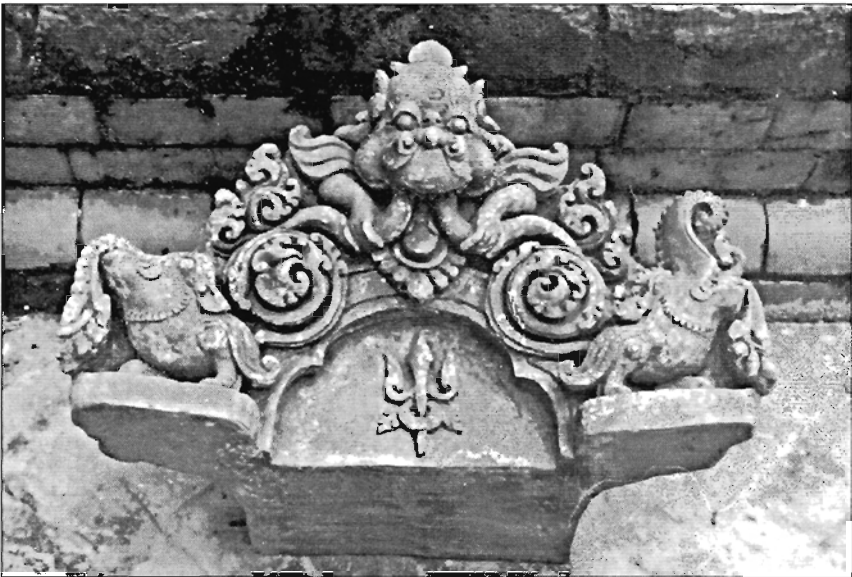
Terracotta after cleaning
