RAMAGRAM EXCAVATION-IV

Sukra Sagar Shrestha

Ramgram Main Stupa

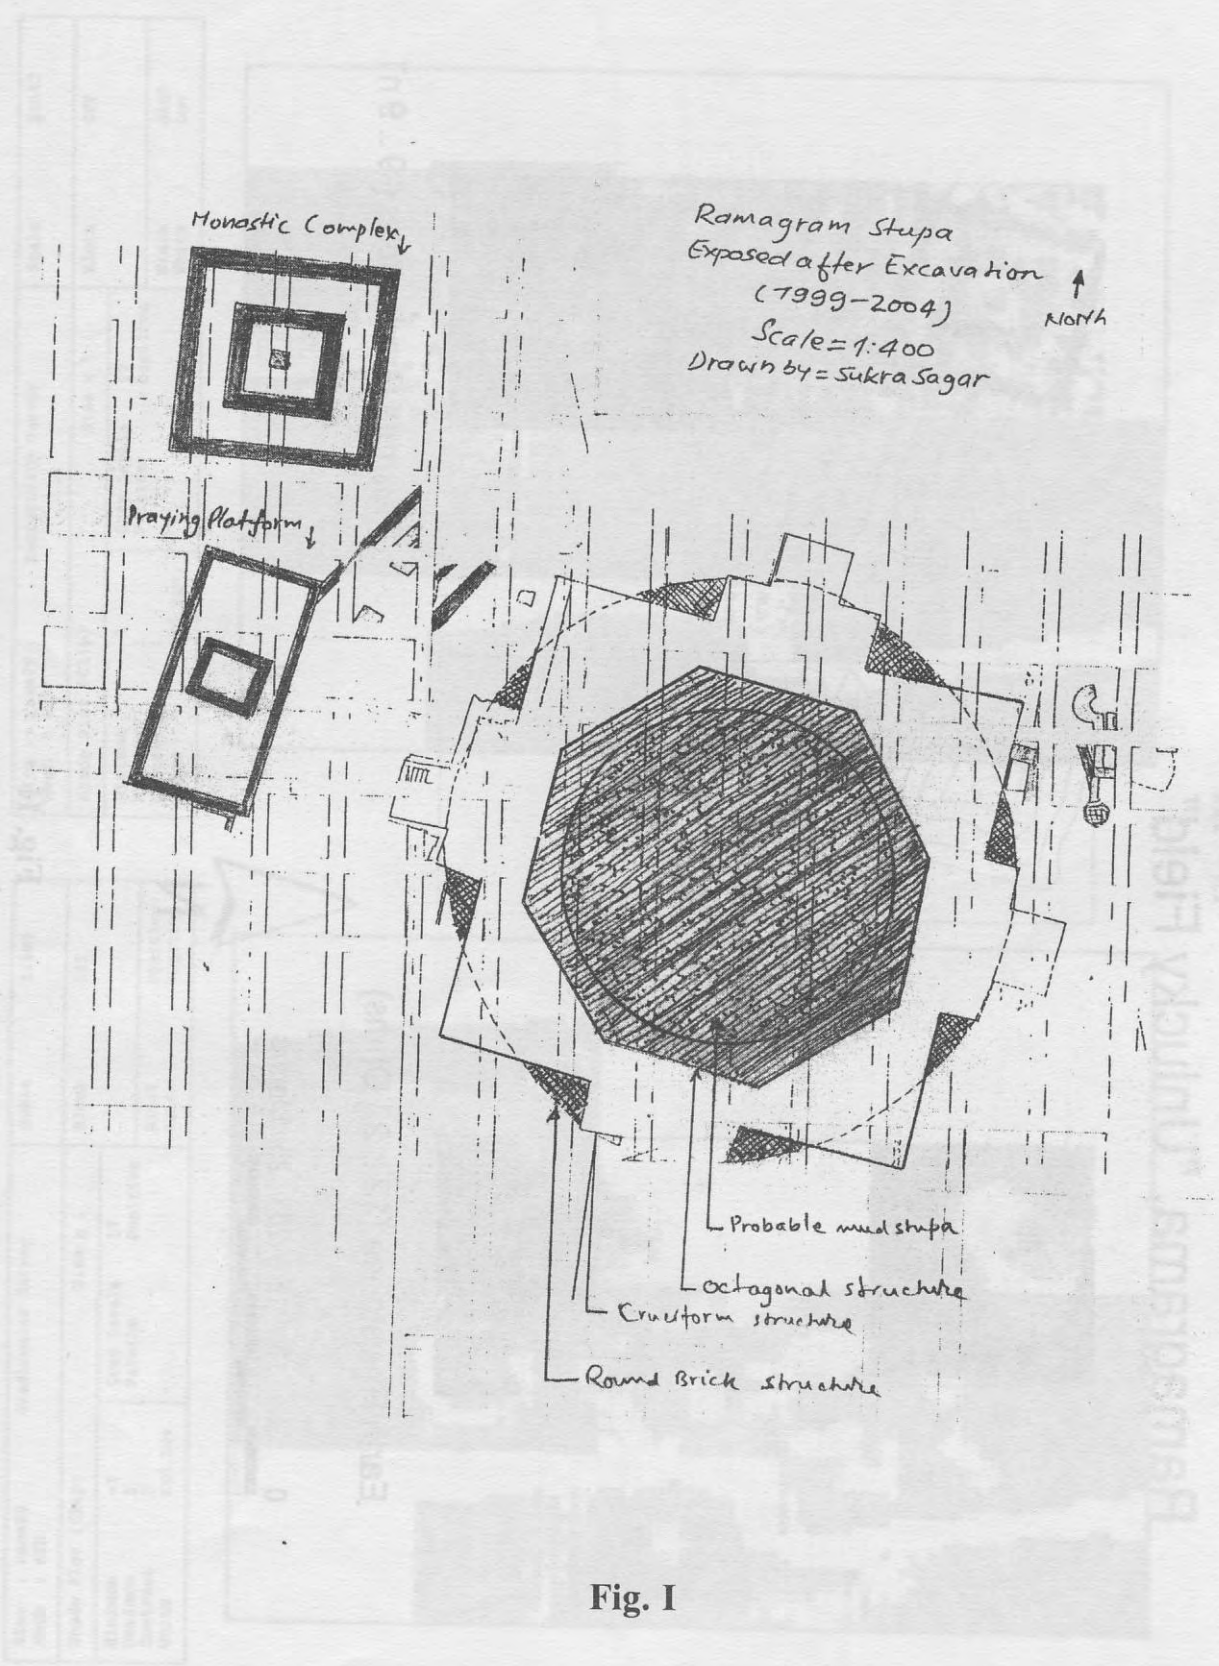
Fig. I

illogical. Therefore we can surmise that the Mouryan people should have covered the mud structure at the center and erected the brick stupa veneering over that, (Fig .I)

The arms of the cruciform structure from the main corner are ten meters long and then extended three to four meters out at right angle. Again goes three meters in and after that three to four meters outstretched (Fig. 1).

Similarly the height of it also should be less than six meters from the natural level because the base of Octagonal structure is measured nearly six meters from natural level. The builders of the octagonal architecture should have laid their base on top of the brick foundation, which should not be other than the brick structure of cruciform build-up. The thickness of the cruciform should be very big, not less than three meters (Fig 1)

If there is mud stupa at the center of the mound the diameter of it will not be more than the diameter of octagonal structure on top because the octagonal structure will not stand on top of the mud. Therefore it should be less than 20m. If the mud structure of Vaisali and Ramagrama stupa are compared and correlated each other then the mud stupa, if any, at the center, will be below the octagonal structure within the enclosure of its eight arms and the foundation should be at least one meter inside the present façade of Octagonal structure.(Fig I, pl 2)

There is an open passage in between the top edge of the cruciform structure and base of the octagonal structure. In first phase the passage was paved with the bricks and later on it was covered again with thick brick canker rammed.(Fig I and Fig VIII)

To the north west of the main stupa at a distance of nearly ten meters away stands a monastic complex of moderate size. This, along with the praying platform, is two conspicuous structures in the vicinity of Ramagram Stupa. (Fig I, Pl.7)

A rectangular structure measuring 8 x 17 meters is exposed to the west of the main stupa with a raised square platform (4x 4.5 m) at the center (fig I). The structure is presumed to be a praying platform.

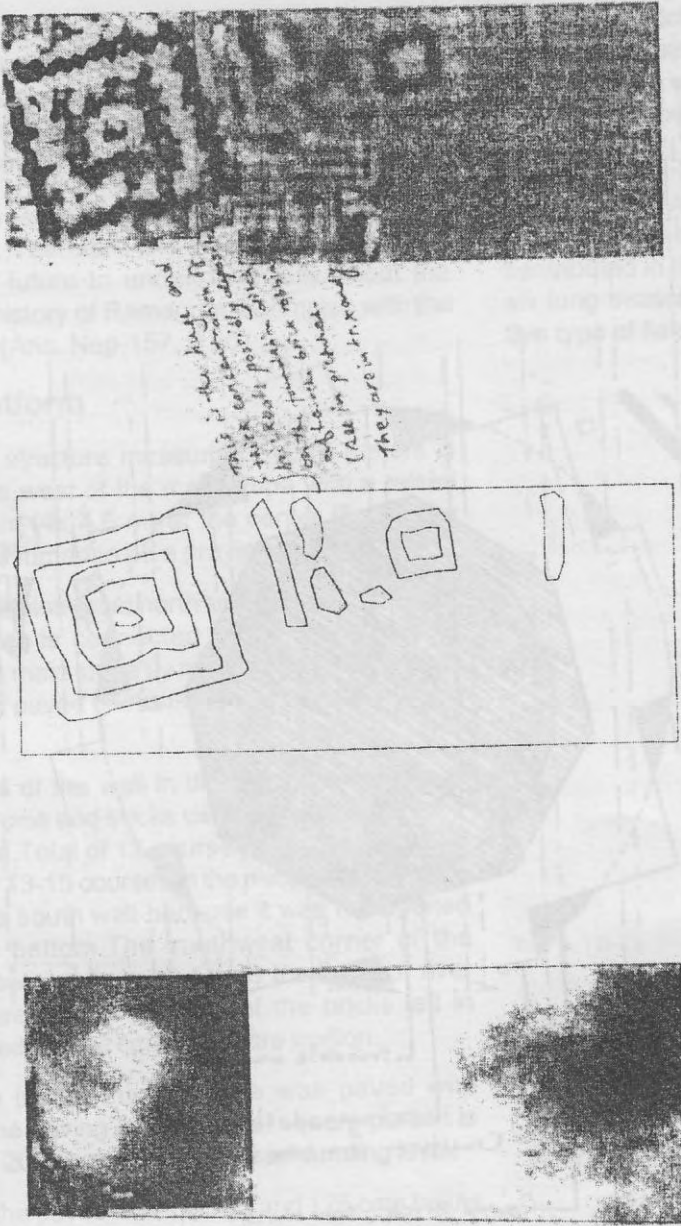
Fig. II

Ramagrama, "Unlucky Field"

Fluxgate Gradiometer (-9 .. 9 nT)

Earth Resistance (12 .. 25 Ohms)

Department of Archaeology immediately conducted the archaeological excavation and found the result as a monastic complex against the interpretation as stupa complex understood by Bradford team.(Fig II)

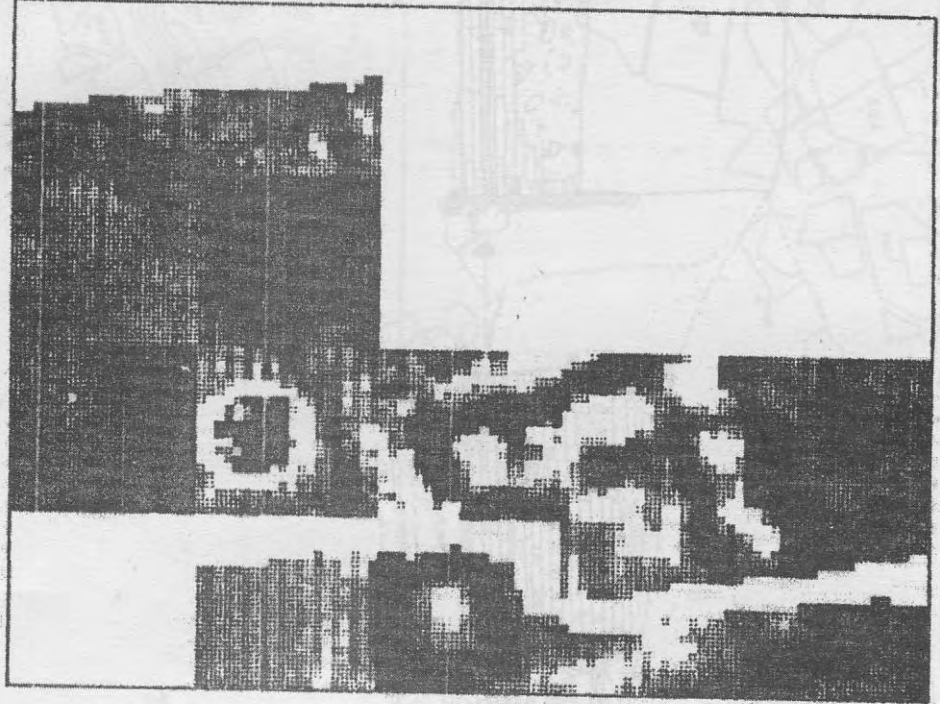
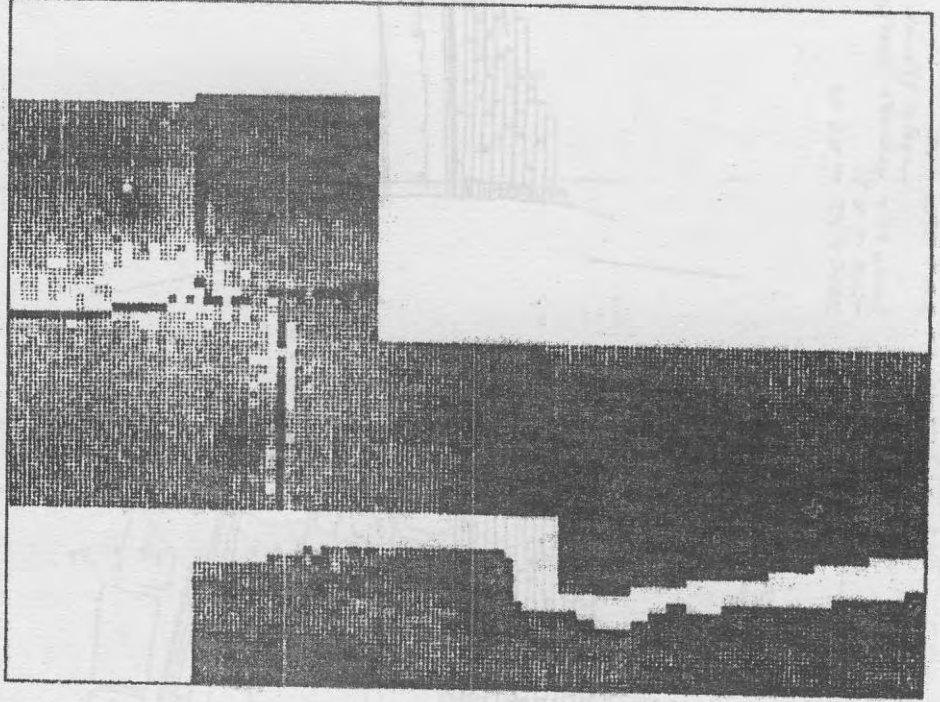
Fig. III

Site : rama99 Mesh : s2M	Gradiometer Survey	Scale 1:443
Shade Plot (Clip)		Block Off
Minimum -1	Grey Levels 17	Positive
Maximum 1	Palette	
Contrast 1	Std.Dev.	
Units		Negative

Site : rama99 Mesh : 62r	Resistivity Survey	Scale 1:443
Shade Plot (Clip)		Block Off
Minimum -1	Grey Levels 17	Positive
Maximum 1	Palette	
Contrast 1	Std.Dev.	
Units		High Low

The textual description given by the Geophysical survey team is not available. But from the comparison and correlation with the same sort of picture from unlucky field, it can nothing but be a monastic complex with a brick structure of a stupa or an oven used for long period of time to the north of it.(Fig III)

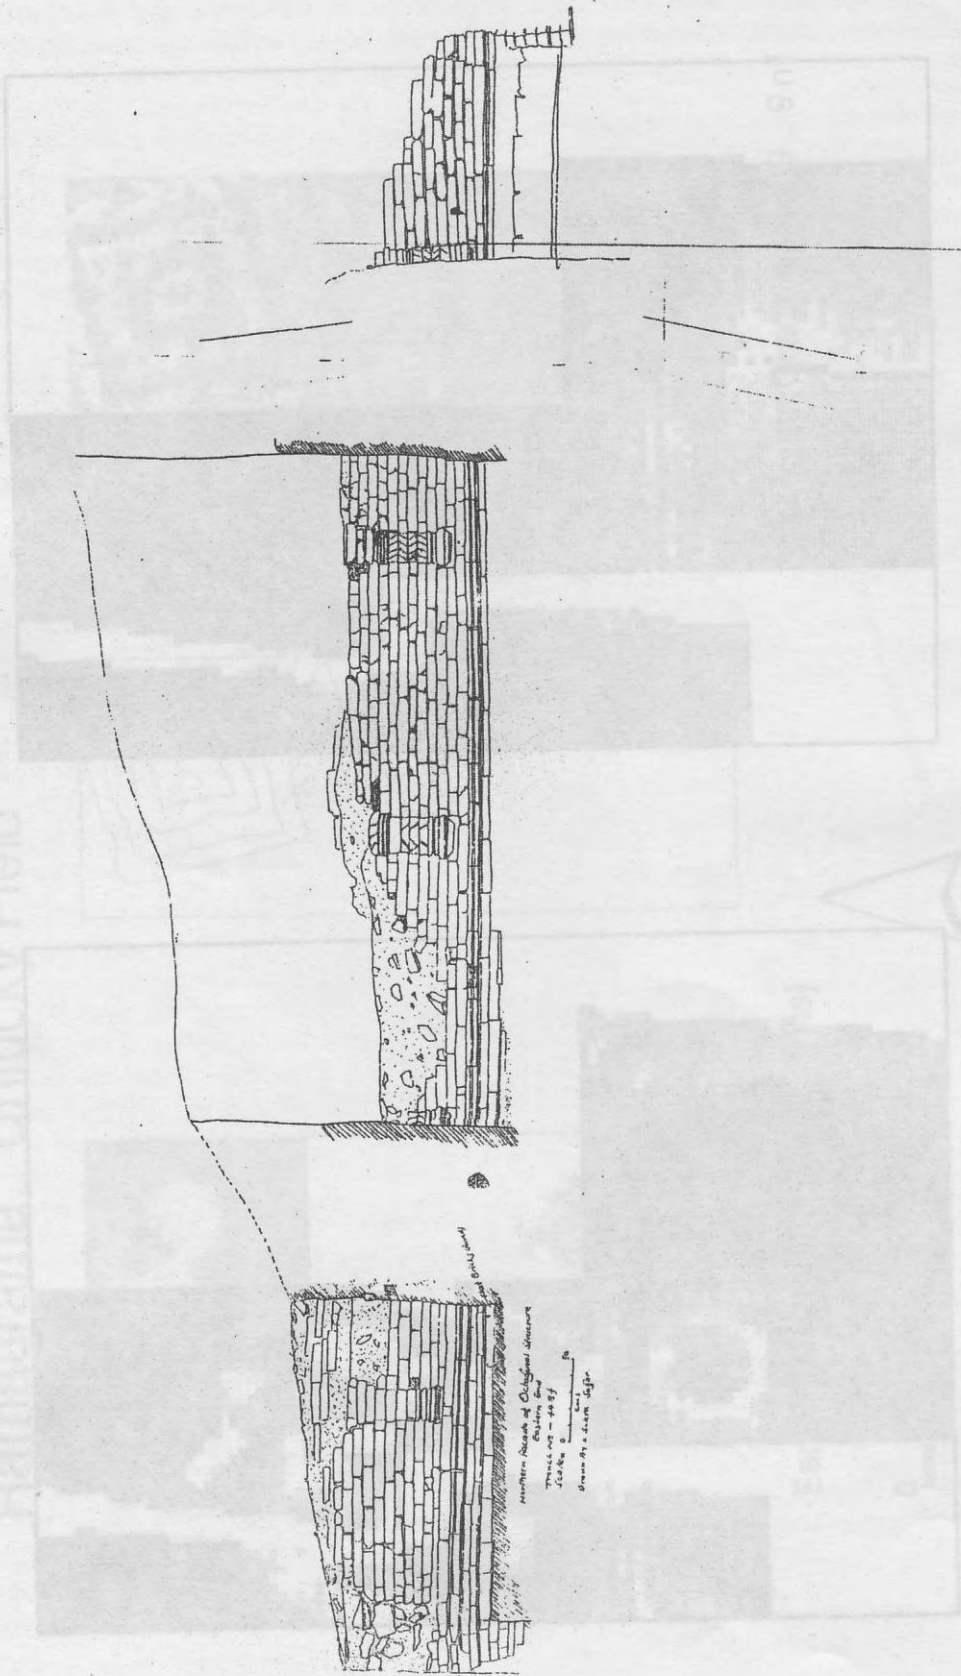
Fig. IV

Vertical Scale of Original Structure
 Trace no. 4487
 Scale 1:1000
 Base of section 4487

A structure in octagonal plan is erected on top of the cruciform architecture. The diameter of this structure is 24 meter and each arms measure 10.25 m in length. As in the structure below, each corner of the octagon is embellished with the carved pilasters with additional five pilasters in between them. The height of it is nearly a meter high (Pl 3 a, b and Fig. IV, V and VI).
