# A Report on the Structure and Conservation of the Temples of Helambu in Nepal

Janak Lal Sharma  
H. Shakya  
T. R. Tamrakar  
J. Sanday  
C. Jest

As an example, a more detailed study of two of the most interesting buildings: Lhaxhang Gyang and Chure Gyang, has been made, detailing their construction and present condition, with notes on their cultural and historical importance.

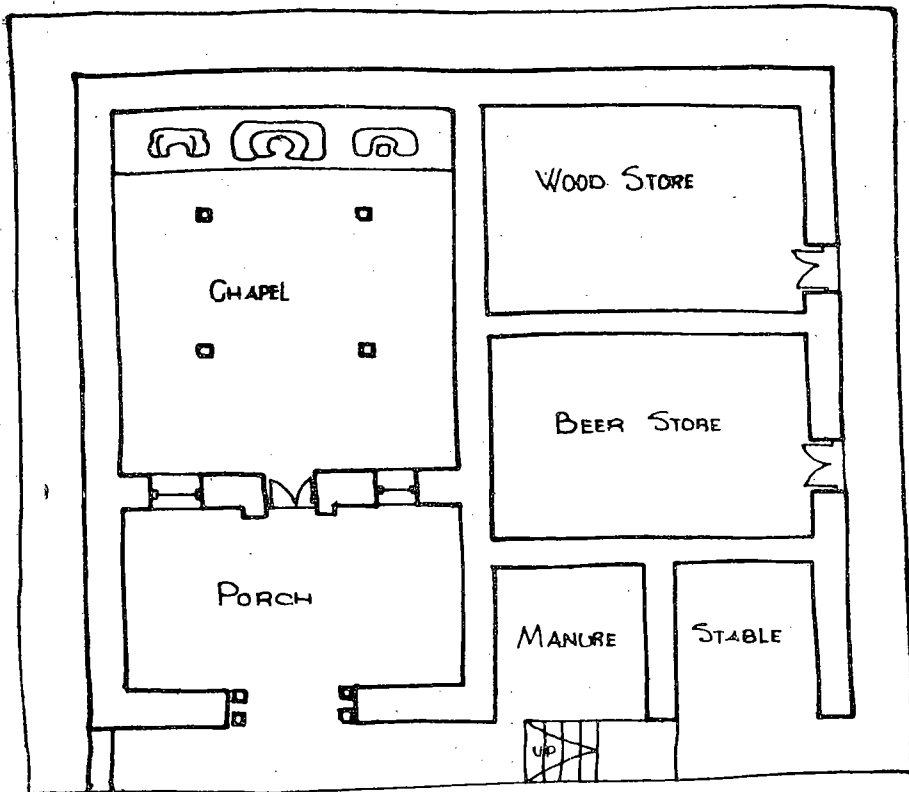
GROUND FLOOR  
 LHAKHANG GYANG — HELAMBU NR/HL/4

**2.04 Ground floor:-** The floor to the chapel is of wide boards set on joists that are set directly on the earth below. There is a similar floor in the portico.

**2.05 Inner Linings:-** The walls are plastered with a mud plaster and decorated with murals of reasonable quality, using a water based paint. The murals are set above a 1.50 metre projecting stone band.

**3.01 General Foundations and Walls:-** It is obvious that the structure of the building has been altered, making the opening to the porch smaller. This alteration was not motivated for structural reasons. However the walling on either side of the opening is out of true. This is not a result of structural weakness, but more the effects of poor building in the first place. The remaining walls are all of reasonably sound construction. (R)

**3.02 Inner Structure:-** The basic structure of the central pillars and the beams is fairly sound but there does seem to have been some lateral movement, possibly as a result of an earthquake. On the Southern wall there are fractures on the interior which are of little consequence but there has been considerable movement in the North Eastern post and bracket. The pillar is inclining slightly and the bracket appears to have slid horizontally. The South Western pillar has a split in it and the bracket has a severe fracture through it. Added to this there is a heavy beetle infestation which is bound to weaken the structure. (R)

building fabric has considerable moisture content. At ground level there is evidence of high moisture as a result of rising damp, especially in the South East corner of the chapel. However the wall paintings begin at the height of almost two metres and are not affected. The North wall is very damp as a result of splashback and a heavy growth of lichen. The passage of rainwater along the back of the building is very poor. (R)

**4.02 Wall Coverings:-** The condition of the wall paintings is good. Although exposed to a very damp atmosphere, they have remained intact because they have not been sealed. Minor defects are apparent as a result of fractures caused, most likely, by earth tremors. The painting in the portico have, due to their exposed position, been affected by moisture but are still in reasonable condition.

**4.03 Ground Floor:-** Because there is high moisture content in the walls, the timber floor adjacent to the walls is liable to be affected by both beetle and fungal attack. Added to this the floor is laid directly on the earth beneath which must be very damp during the heavy rains. The space beneath the floor is full of debris which also attracts moisture. The floor to the portico is very uneven. (R)

**4.04 Ceiling and Roof Space:-** Generally the condition of the ceilings is satisfactory. There are signs of damage caused by earlier water penetration and there is evidence of beetle attack in the North East corner. The ceiling to the porch at one time had a painted Mandala design on it and this has now been removed and parts of it are still to be found in the building. (R)

**4.05 Roof Covering:-** The shingle roof covering is well maintained and the present shingles were turned five years ago and it is reported that the roof is watertight over the temple but that there is some leakage over the dwelling. (R)

**R. 3.01** It is necessary to keep a careful check on the movement in the walls and it may be necessary to stabilise the fractures either by rebuilding the section of walling and bonding across the fracture or the insertion of small concrete bonders in the critical places.

**R. 3.03** The roof structure should be treated against beetle and fungal attack and the defective timbers should be checked and if necessary replaced.

**R. 4.05** The roof coverings are always the most prone to decay. The shingle covering is very traditional in this area and it is important to retain this tradition. It is proposed that roofs should in future be treated with a silicone based chemical which will protect the shingles from both fungal attack, as the result of heavy saturation, and from beetle attack as the timber used is very susceptible.

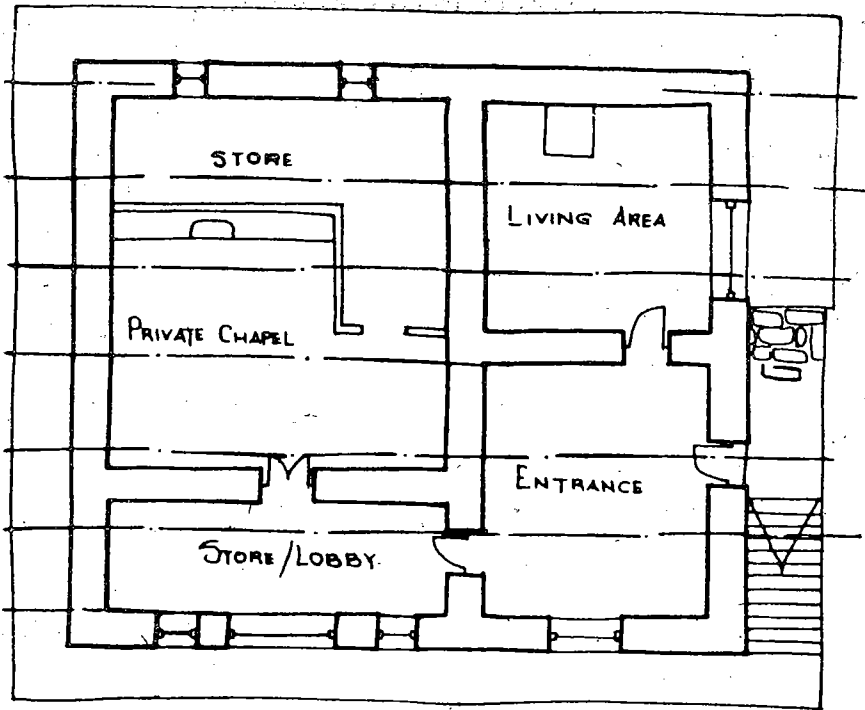
FIRST FLOOR  
CHURE GYANG

**3.01 General Foundation and Walls:-** The effects of earth tremors and earthquakes are in evidence on all the elevations. On the West elevation the most recent tremors, it is said, were the cause for the fractures and especially the more severe fracture rounding through the length of the building. Further effects are to be seen on the East elevation though these are of little significance. The South elevation, having several openings in it shows signs of structural movement, especially in the South Western corner, and at the Western end of the porch. (R)

**3.02 Inner Structure:-** The basic structure of the temple seems sound, but there is evidence of fairly heavy beetle attack in the majority of the timbers. The main timbers have a series of fractures in them. The beams have several horizontal fractures and the North West post has a vertical fracture, both of which are not liable to cause structural weaknesses. (R)

**4.02 Wall Coverings:-** The conditions of the wall linings is surprisingly good. There is evidence however that some damage has been caused by condensation although the readings taken at the time showed little indication.

**4.04 Upper Floor and Ceilings:-** Part of the ceiling on the Eastern side has been replaced. All the ceiling timbers are suffering from heavy beetle infestation. (R)

**4.05 Roof Covering:-** Although quite old, the shingle roof covering is maintained in reasonable condition. Its life expectancy is however running short. (R)

**R. 3.01** It will be necessary to monitor all fractures to establish if they are alive. When the roof is relaid it would be advisable to consolidate the defective sections either with well bonded stonework or in the more serious cases with short concrete bonders.

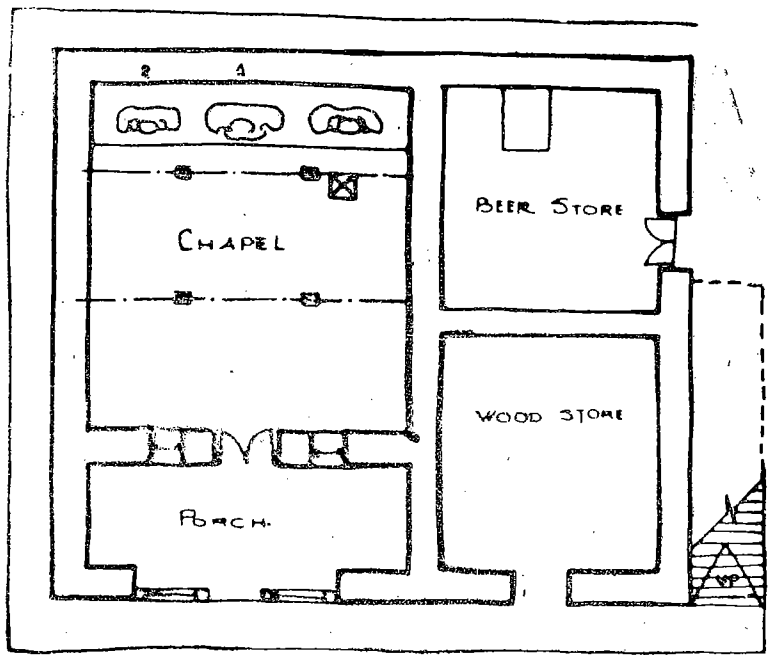
GROUND FLOOR  
CHURE GYANG

**2.04 Ground Floor:-** The floor is boarded floor which has probably been recently laid as the boards are of narrow width. Some of the original boards still remain at the West end. The porch is also boarded over with wide planks but there is a stone threshold to the door.

**2.05 Inner Linings:-** The walls are plastered over with a mud plaster and decorated with murals painted in a water based paint above a plain dado of 1.50 metre. There is a similar lining to the walls of the porch.

**4.03 Ground Floor:-** The floors have been relaid probably as a result of the earlier floor having disintegrated from fungal and beetle attack. The conditions are still the same as there is no under floor ventilation and there is considerable dampness as well as debris below the floor. There is considerable beetle attack throughout the planking. (R)
