A Contribution to the Preservation of the Cultural Heritage of Nepal: The Restoration of the Brahmayani Temple in Panauti

— Riddhi Pradhan

The Brahmayani Temple

The restoration work

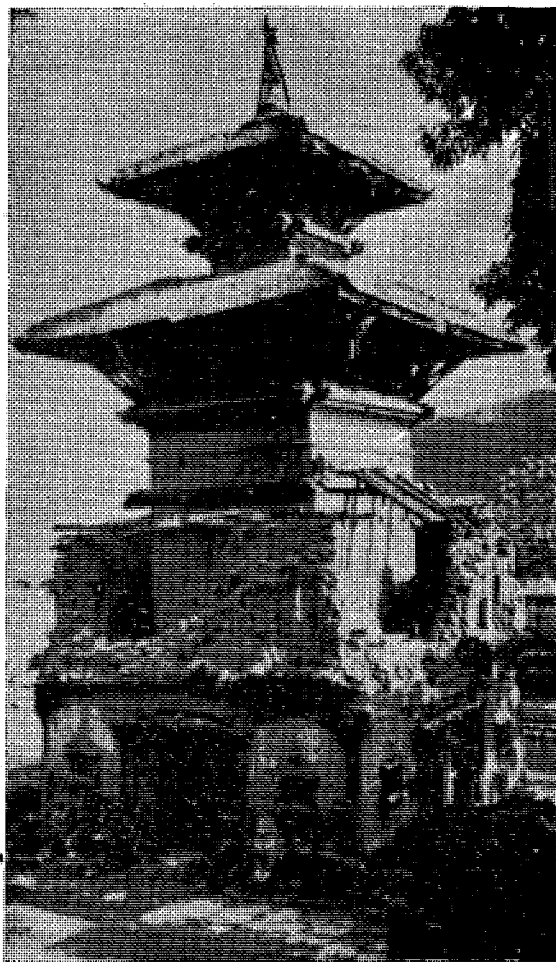
Because of lack of maintenance and conservation through years, this temple had reached a very dilapidated state. Most of its wood carvings were disfigured or lost. (Pl. No. 3 A and 3 B)

(A) Brahmayani Temple before restoration

1. Prior to the starting of actual restoration work the heap of fallen material from the temple were carefully examined and the reusable materials were kept aside in safe custody. The other materials were removed from the temple surrounding and made the temple area clean.
2. Scaffolding work was done by an expert in this field. Immediately after scaffolding the pinnacle was removed and stored in the office.
3. The walls and roofs of each storey were systematically dismantled and these were stacked carefully for future use. (Pl. No. 4 A.)
4. All the wooden artifacts were registered while they were being removed from the temple.
5. The four central pillars inside the temple were strengthened with R.C.C. foundation to protect them from further sinking.
6. Similarly the ground floor walls were reinforced by R.B.C. foundation.

7. The temple was reverted back to its balance as it was tilted by about 4" towards its eastern side.
8. The masonry work started from bottoms-up.
9. The carpentry and roofing works started from top-downwards and the Gajur, after its cleaning and repairing was re-instated in its original place.
10. After the completion of the temple, wall paintings were restored and chemically treated.

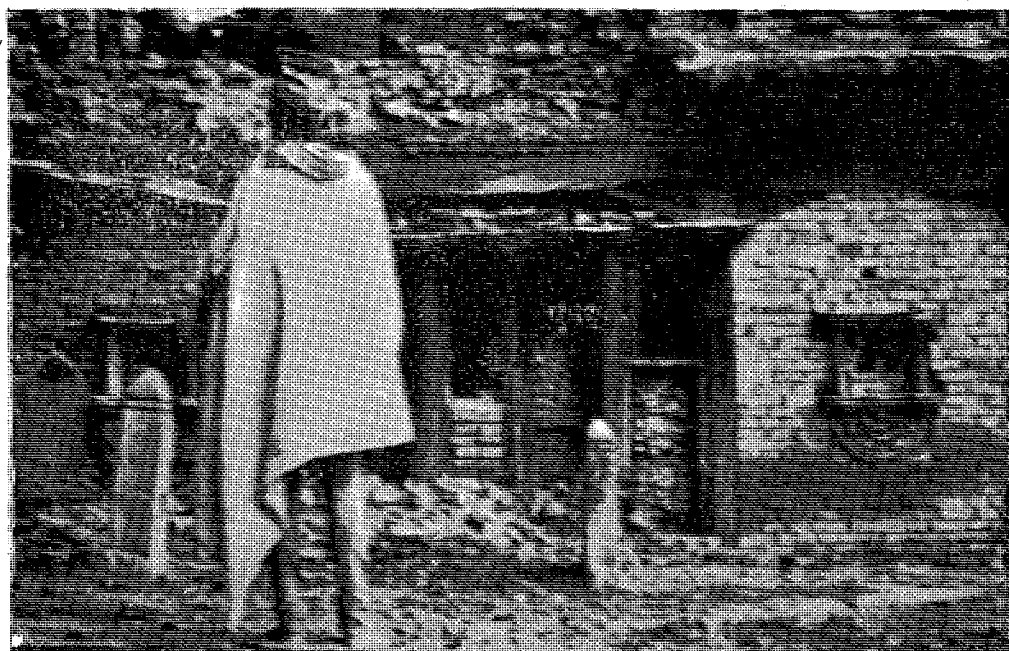
(B) A close-up view of western entrance of Brahmayani Temple

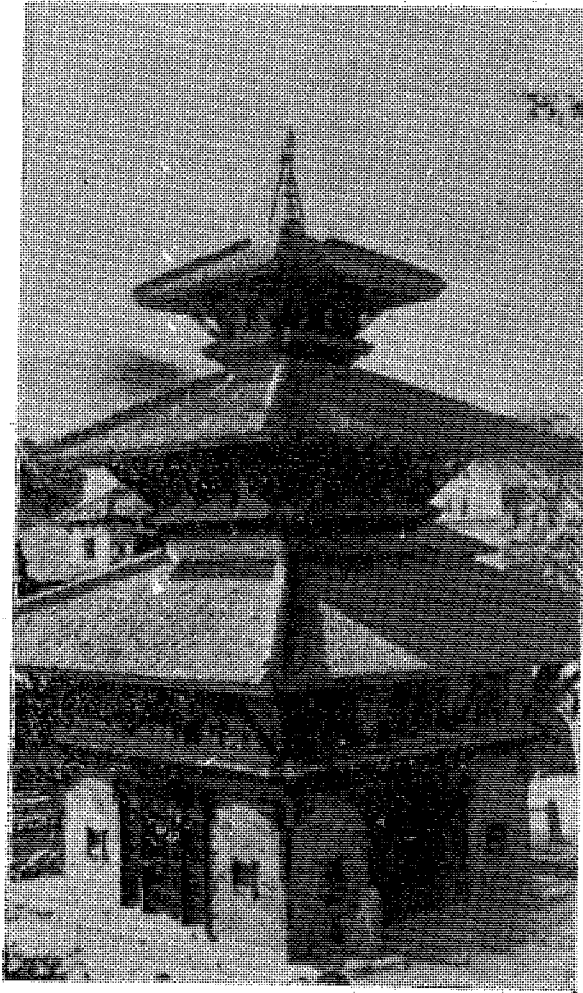
Panauti is a small township. It is a Newar settlement with numerous architectural monuments; the Brahmayani Temple is one of the major temples. But lack of maintenance through years it was in very bad shape. With the assistance of French Government (CNRS) the temple has been restored in its original shape. (Pl. No. 7 A and 7 B.)

(A) Brahmavani Temple after restoration
