Kungri Tsuglakhang Murals Conservation-Restoration Project

Mélodie Bonnat
(Paris)

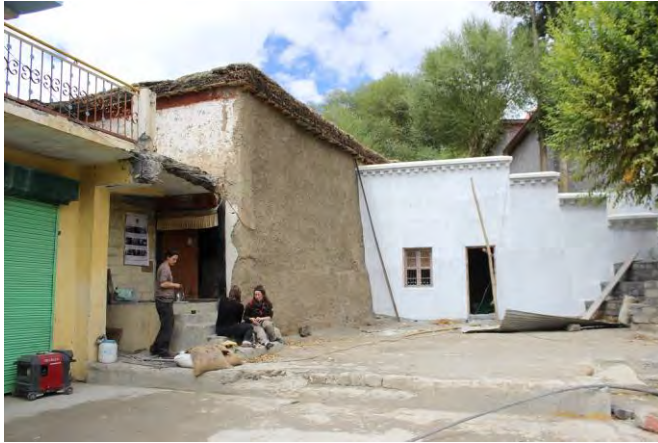
Fig. 1 — The Tsuglakhang in 2016.

The exterior of the Tsuglakhang is in perpetual state of renovation. In 2015, the monastery's head decided to dismantle a concrete terrace built in 2004, as well as the additional rooms surrounding the two shrines. The monks, advised by our team, wanted to set up a small garden to valorise a natural water source, which springs in summer time. The channelling of the watercourse would also have protected the building from eventual dampness damage. However, the results visible in 2016 were different from the proposal given by us. Instead, a concrete flight of steps is now leaning against the temple and the garden is unlikely to be set up (Fig. 1).

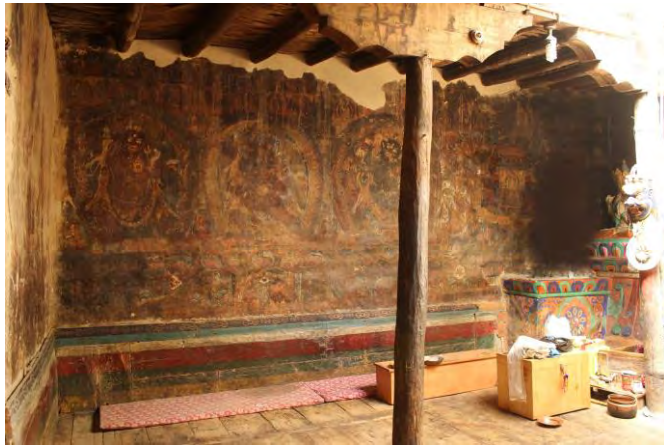
Fig. 2 — The Tsuglakhang in 2016, after the conservation intervention.

Despite the altered aspect of the temple outside, embedded in modern constructions, its interior can still be considered as authentic. The Tsuglakhang is a small forty-two square meter room with four wooden pillars (Fig. 2). A low traditional wooden ceiling is three

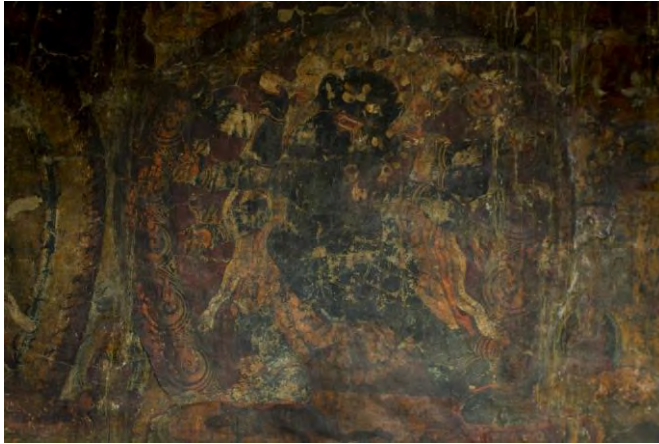
Fig. 3 — *Che Mok Heruka* after 2016 intervention.

Due to budget restrictions, we could analyse only a single sample of paint from the Tsuglakhang, which nevertheless yielded numerous results. The sample was taken from the blue body of the third standing deity located in the middle of the south wall called *Che mchog he ru ka yab yum* (Fig. 3).

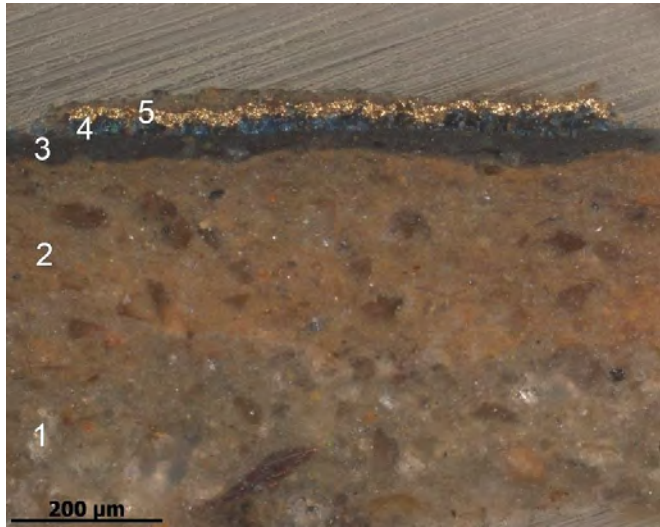
A micro stratigraphy was conducted by the laboratory Epitopos in Strasbourg, thanks to the Ashoka Grant from the Khyentse Foundation. The cross section obtained under microscope shows a multilayer stratigraphy of the painting, from the structure of the wall to its surface (Fig. 4). First, in the lower portion of the sample lies the superficial part of the mud plaster (layer 1 in the picture). Secondly, the preparatory layer applied on the plaster is a thick and intense orange layer made of red ochre, which can be seen with the naked eye observing the paint layer losses (layer 2). This orange layer is surprising as preparatory layers usually identified on Himalayan wall paintings and thangkas are made of white substance such as calcium carbonate or kaolin. No reference is made to an orange preparatory layer. The third layer, which overlies the orange preparation, is a black under-layer made of charcoal (layer 3). The fourth layer, i.e. the visible paint layer, is made of ground azurite, a precious stone and blue mineral (Fig.5) (layer 4).

Fig. 4 — Cross-section of a sample analyzed by Epi-topos.

Returning to the micro stratigraphy, a fifth layer made of gold was thinly applied on top of the blue (layer 5). It was used to depict and enhance the jewellery, eyebrows, and eyelashes of the deities (Fig. 6).

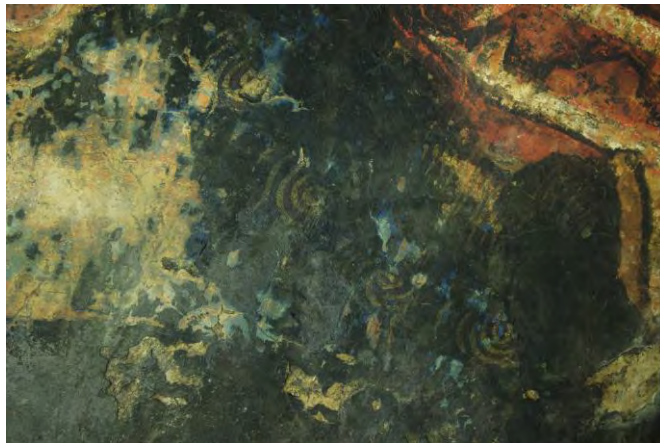
Fig. 5 — Detail of the deity Che mchog he ru ka yab yum whose skin is painted with azurite on the south wall.

It is a well-known technique used in Europe and in Asia. A black under-layer made of a cheaper material is used in order to enhance the hue of the expensive azurite blue. This technique is also attested in Nako (Kinnaur, H.P.),¹⁵ in Ladakh (J&K),¹⁶ and in Bamiyan

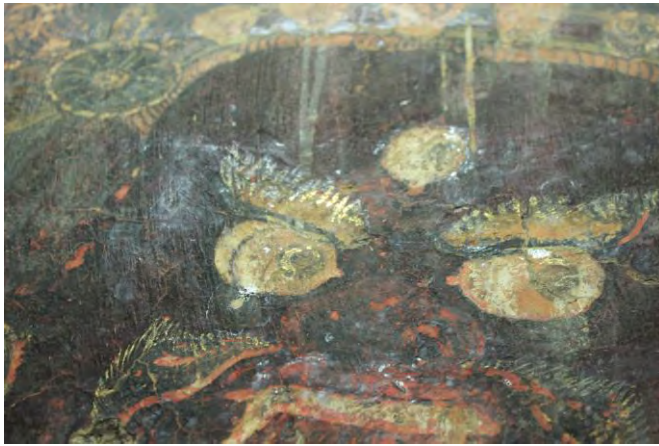
Fig. 6 — Detail of gShin rje whose eyebrows are painted with gold powder on the south wall.

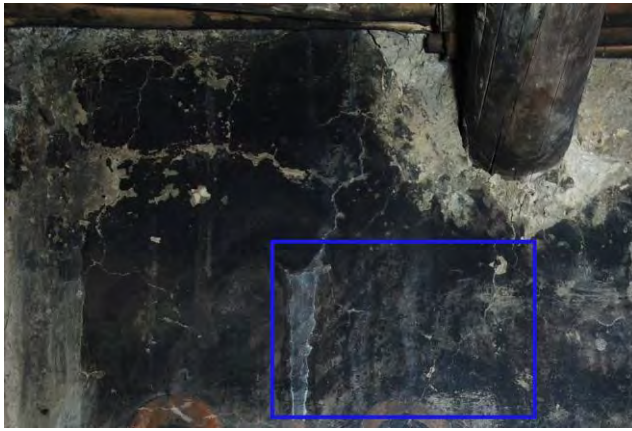
Fig. 7 — Detail of the south wall before cleaning; the blue square localize the next detail.

Next we proceeded to numerous varnish removal tests. The best result was obtained with the use of isopropanol compresses made with facial tissue applied on the varnish for two minutes, before being cleaned with cotton swab and isopropanol. The result was satisfying and homogenous, preserving the original colours underneath. It eliminated the shining effect of the varnish, providing a better view of the paintings (Fig. 7 and Fig. 8).

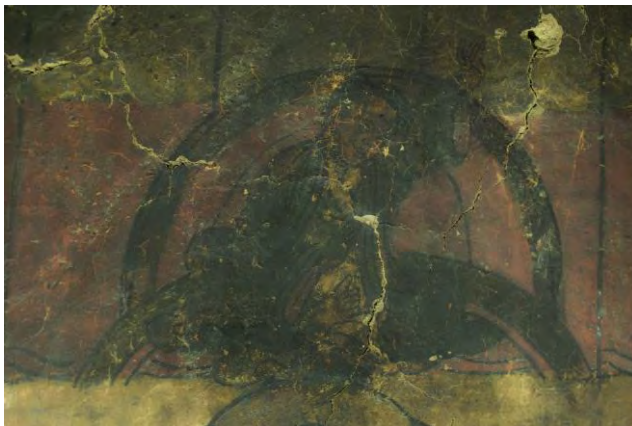
Fig. 8 — Detail of the south wall after cleaning; one of the followers of Padmasambava.

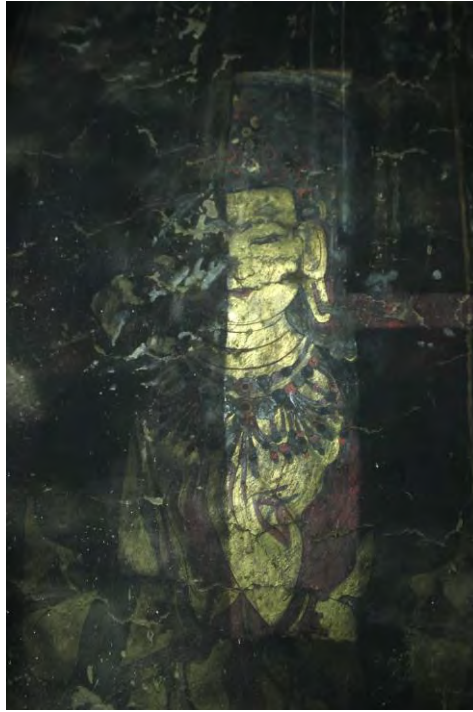
Fig. 9 — Detail of the north wall during cleaning (Credit E. Aubert).

Finally, and for more resistant areas, lipophilic neutral or slightly alkaline hydrogels prepared with Pemulen[®]TR2,²⁷ and various alkaline salts such as ammonium hydroxide and bis-tris methane.²⁸ These methods would seem quite extreme on this type of paintings but they are admittedly the only way to produce a chemical reaction with the polar and oxidized soot deposit, and thus diminish its opacity without altering the appearance of the original colours. In view of the satisfying results obtained, it was decided not to test other and more aggressive methods that could cause abrasion or deterioration of the paint layer (Fig. 7 and Fig. 8). In the future, the methods developed for the south wall could also be used on the other walls of the room. On the north wall for example, tests have been carried out revealing a gold pigment used for the skin of deities (Fig. 9) where cleaning methods were effective.

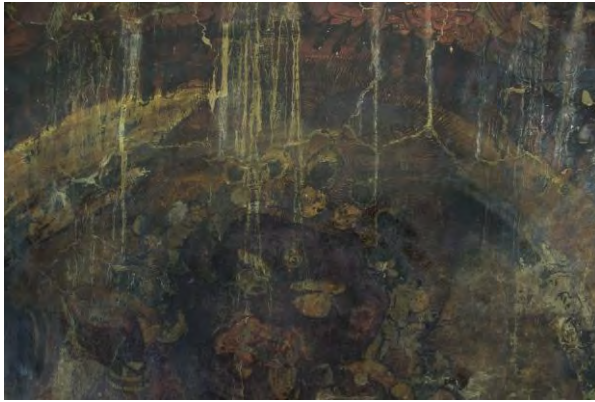
Fig. 10 — Detail of *rTa mgrin yab yum*'s head during cleaning.

In this way, we could identify on the east wall, just on the right side of the door, two of the Four Guardian Kings (*rGyal chen bzhi*); *Phag skyes po* holding a sword, and the *Yul 'khor srung* playing a music instrument. The two other Guardian Kings are visible under the soot on the left side of the door. On the left part of the south wall, Henry identified three large deities, namely *gShin rje*, *rTa mgrin yab yum*, *Che mchog he ru ka yab yum*, who are all *Yidam* related to the Pema Lingpa tradition (Fig. 3 and Fig. 10).

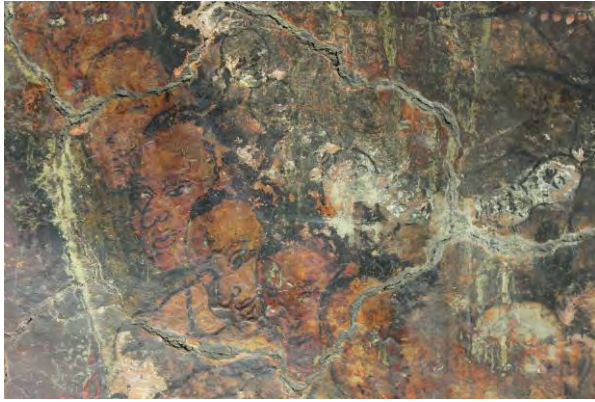
Fig. 11 — Detail of rTa mgrin yab yum's belt of heads.

Unidentified religious figures wearing lotus hats or a turban were painted between these *Yidams*. Similar religious figures are also represented on the west wall but could not be identified (Fig. 11).

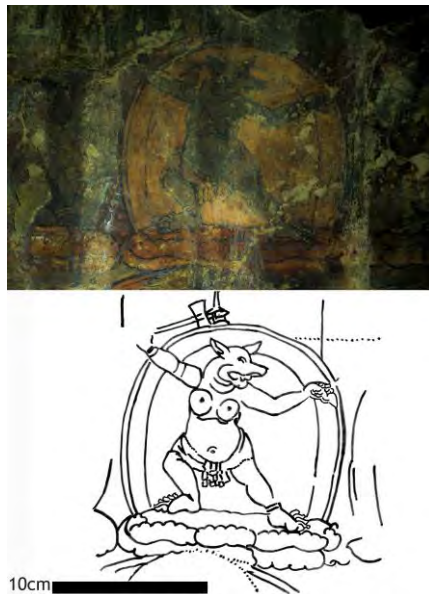
Fig. 12 — One of the hundred peaceful and wrathful deities, photography and tracing.

located three meters above the floor. We thus decided to trace the outline of each figure by using transparent plastic sheets and permanent markers. Each drawing was then scanned and processed through a graphic software.

On the upper part of the wall, thirteen of the twenty-five disciples of Padmasambhava, followed on the right by some of the hundred wrathful and peaceful deities (Fig. 12) are disposed all along the wall underneath the ceiling, and continuing the west wall and behind the altar. It is necessary to resume the cleaning of the paintings to complete the iconographical study of the figures painted in the temple, thus understanding its religious lineage and history.
